Article Hydrogen Embrittlement Behavior of 18Ni 300 Maraging Steel Produced by Selective Laser Melting

Abstract: A study was performed to investigate the hydrogen embrittlement behavior of 18-Ni 300 maraging steel produced by selective laser melting and subjected to different heat treatment strategies. Hydrogen was pre-charged into the tensile samples by an electro-chemical method at the constant current density of 1 A m⁻² and 50 A m⁻² for 48 h at room temperature. Charged and uncharged specimens were subjected to tensile tests and the hydrogen concentration was eventually analysed using quadrupole mass spectroscopy. After tensile tests, uncharged maraging samples showed fracture surfaces with dimples. Conversely, in H-charged alloys, quasi-cleavage mode fractures occurred. A lower concentration of trapped hydrogen atoms and higher elongation at fracture were measured in the H-charged samples that were subjected to solution treatment prior to hydrogen charging, compared to the as-built counterparts. Isothermal aging treatment performed at 460 °C for 8 h before hydrogen charging increased the concentration of trapped hydrogen, giving rise to higher hydrogen embrittlement susceptibi

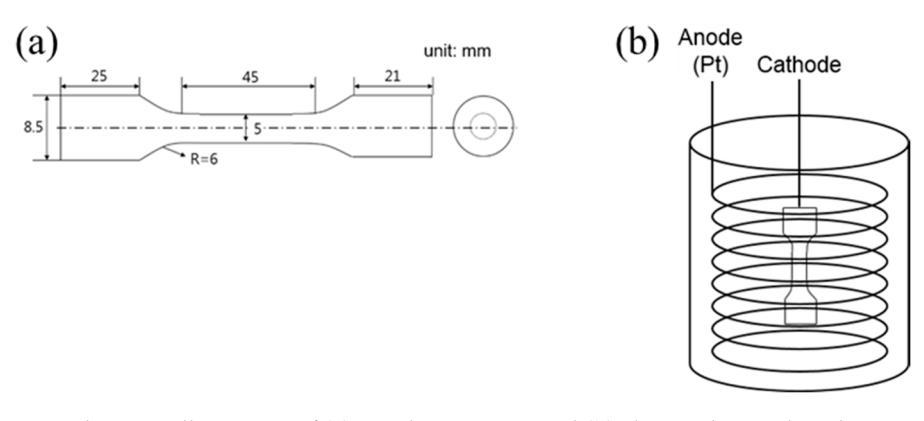
Figure 1. Schematic illustration of (a) tensile specimen and (b) electro-chemical H-charging cell.

The printed and heat-treated sample bars were machined in order to produce cylindrical dog-bone specimens with a gauge length of 45 mm and a diameter of 5 mm (Figure 1a). Tensile tests were performed at room temperature with an initial strain rate of $10-5 \text{ s}^{-1}$, using universal testing machines (INSTRON 8501 or MTS Alliance RT/100) equipped with an extensometer. Fractured surfaces were observed by SEM. X-ray diffraction (XRD) patterns were collected using a Rigaku Smartlab instrument. Cu K α (k = 0.15418 nm) radiation was employed. Peak identification and quantitative analysis of phases was performed by the Rietveld method.

Hydrogen was pre-charged into the tensile samples by the electro-chemical method. The samples were immersed in distilled water solution containing 3 wt.% NaCl and 0.3 wt.% NH₄SCN and were then connected to a cathode. A Pt coil was connected to the anode (Figure 1b). Firstly, hydrogen ions in the solution were adsorbed by the sample surface and consequently absorbed. The process was performed at the constant current densities of 1 A m⁻² and 50 A m⁻² for 48 h at room temperature. After the tensile test, the desorption rate and concentration of hydrogen in broken dogbone specimens was quantified using quadrupole mass spectroscopy (Q-mass). The samples were heated from room temperature to 600 °C at a constant heating rate of 100 °C/h.

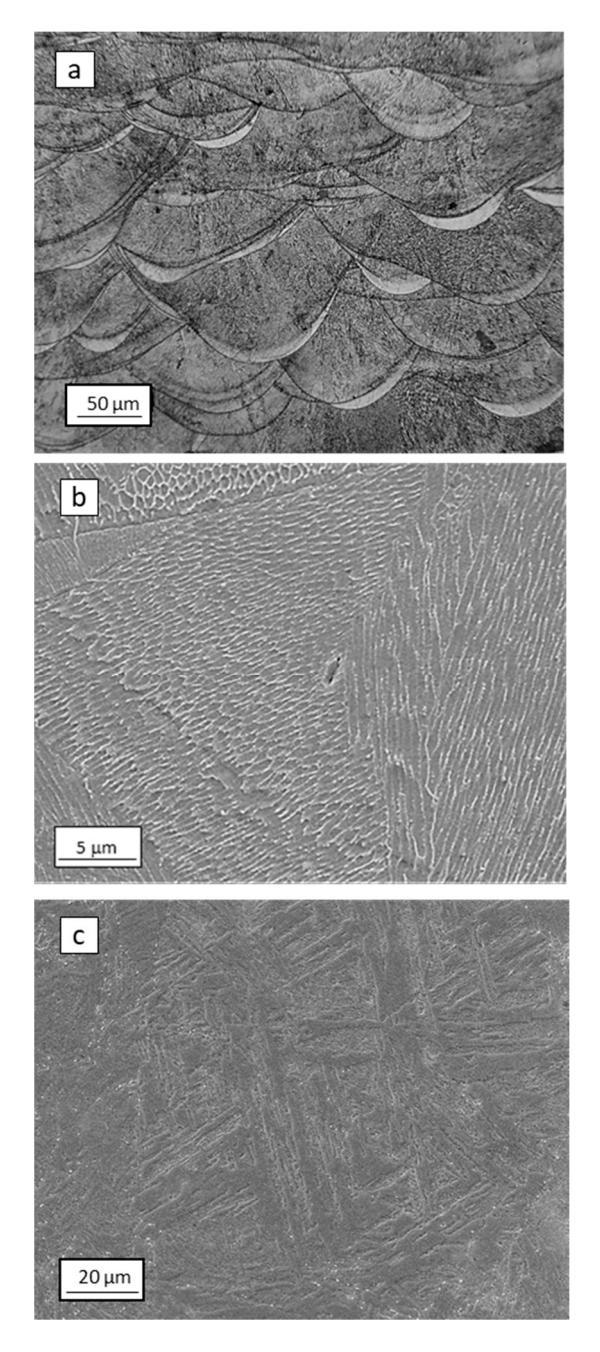
Figure 2. (a) Optical micrograph and (b) SEM image of as-built material; (c) SEM image of the alloy after solution treatment at 815 °C followed by water quenching.

Maraging steel specimens were successfully produced by SLM and showed an average density of 99.8%. Figure 2a shows an optical micrograph of the section parallel to the building direction of the AB material. As already shown in previous works [6,12], solidified melt pool boundaries become visible after chemical etching. The high magnification SEM image of Figure 2b reveals the expected cellular solidification structure, characteristic of many highly-alloyed materials processed by SLM [6,12–16], with a cell size smaller than 1 μ m. Cells are surrounded by a bright-contrast network that in previous works was identified as solute-rich high dislocation density regions [6,12,17]. Consistent with this, the high magnification bright field TEM image in Figure 3 shows high dislocation density regions surrounding the primary cells. After solution treatment performed at 815 °C for 30 min followed by water quenching, the solidification cellular structure was replaced by a martensitic structure, as depicted in Figure 2c. Rietveld analysis revealed that AB and AB-aged steels contained 11.4% and 15.6% of γ -iron, respectively, whereas ST and ST-aged steels contained 4.1% and 5.5% of γ -iron, respectively.

have showed that several alloys processed by SLM can be directly age-hardened without being previously solution-annealed and water quenched [12,18,19]. Indeed, the small melt pools generated by laser, which are a few tens of micrometers in width (Figure 2a), solidify and cool at a high rate, generating extended supersaturated solid solutions that can be effectively exploited by direct aging for precipitation strengthening of the alloy [12,18,19].

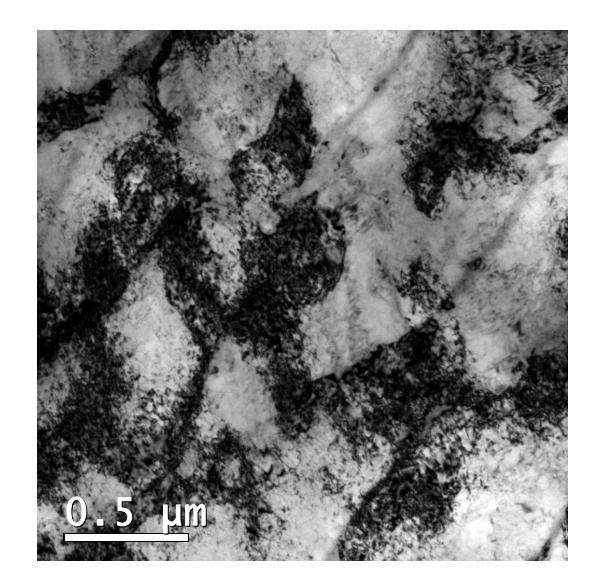
Figure 3. TEM image (bright field) of as-built material.

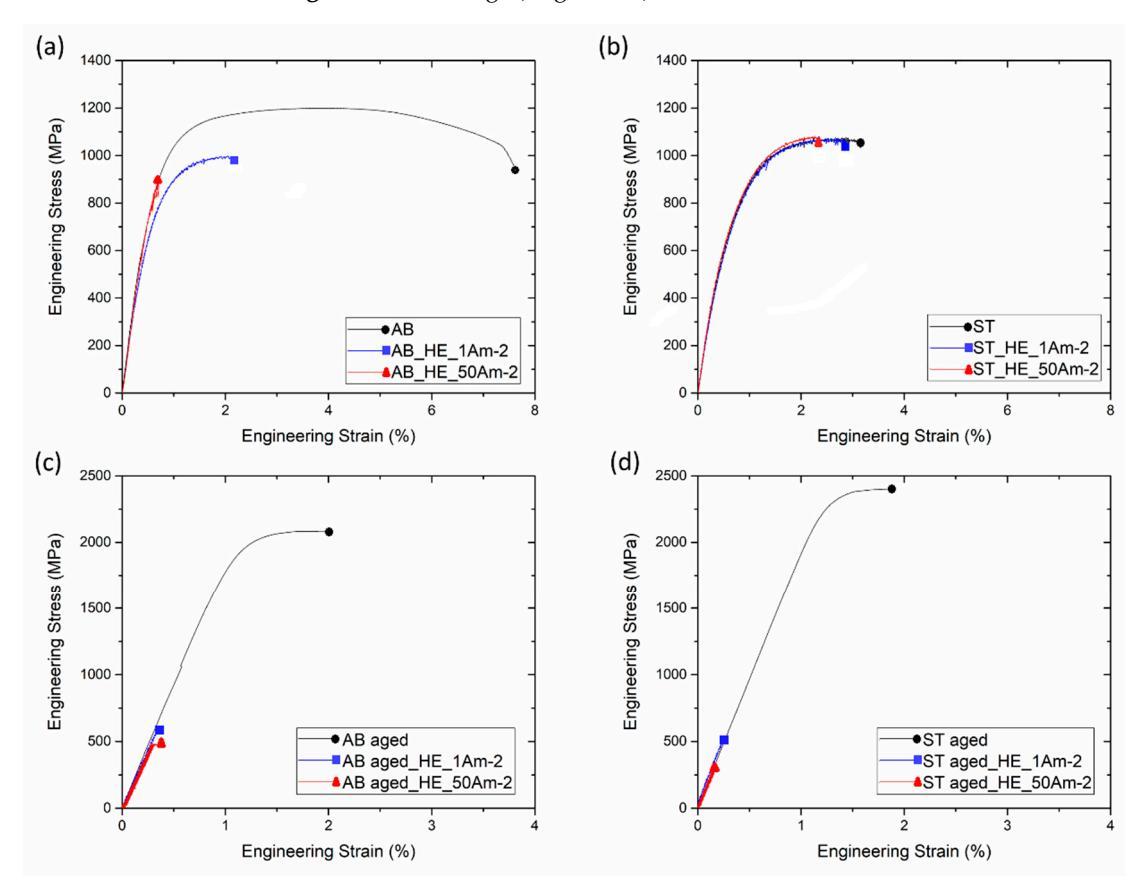
Figure 4. Stress-strain curves of (**a**) as-built (AB), (**b**) solution treated (ST), (**c**) AB-aged, and (**d**) ST-aged samples before and after H-charging at 1 A m^{-2} and 50 A m^{-2} for 48 h.

In Figure 4, the tensile curves of H-charged and uncharged specimens are reported. Tensile tests were performed on specimens that were doped with hydrogen using two different current density levels, namely 1 A m⁻² and 50 A m⁻². The trends of strength and elongation as a function of H-charging conditions are shown in Figure 5. AB alloy shows ultimate tensile strength (UTS) of 1178 MPa and elongation at rupture (ε_r) of 7.6%. Solution treatment led to reductions in strength (UTS = 1076 MPa) and ductility (ε_r = 3.1%). Additional aging treatment for 8 h at 460 °C increased the strength of the AB alloy (UTS = 2095 MPa) and, in particular, that of the ST steel (UTS = 2401 MPa), but it also radically reduced the ductility of the materials. Indeed, the ε_r of AB-aged and ST-aged alloys was 2.0% and 1.9%, respectively.

As shown in Figures 4 and 5, steel samples that underwent solution annealing at 850 °C for 30 min showed lower tensile strength than the as-built alloy, likely because of the stress-relieving effect and slight microstructural coarsening. In ST samples, aging treatment performed at 460 °C for 8 h increased strength up to 2401 MPa, but reduced material ductility (ε r decreased from 3.1% to 1.9%). The strengthening effect is ascribed to the formation of Ni₃Ti and Ni₃Mo precipitates during aging, as widely described in [1–6]. The same aging treatment performed on AB samples was responsible for an increase in UTS to 2095 MPa and for a drastic drop in ε r from 7.6% to 2.0%. Previous works

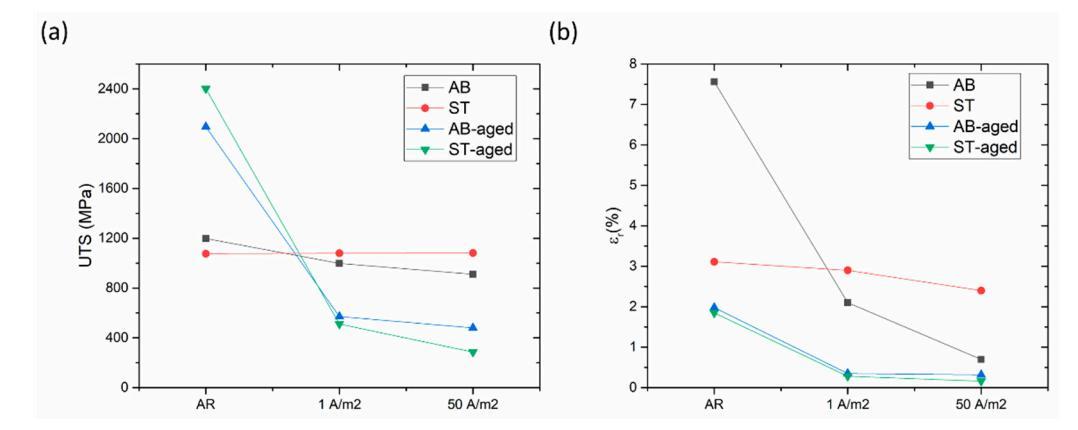
Figure 5. Overall trends of (**a**) ultimate tensile strength and (**b**) elongation at rupture as a function of current density levels applied for H-charging.

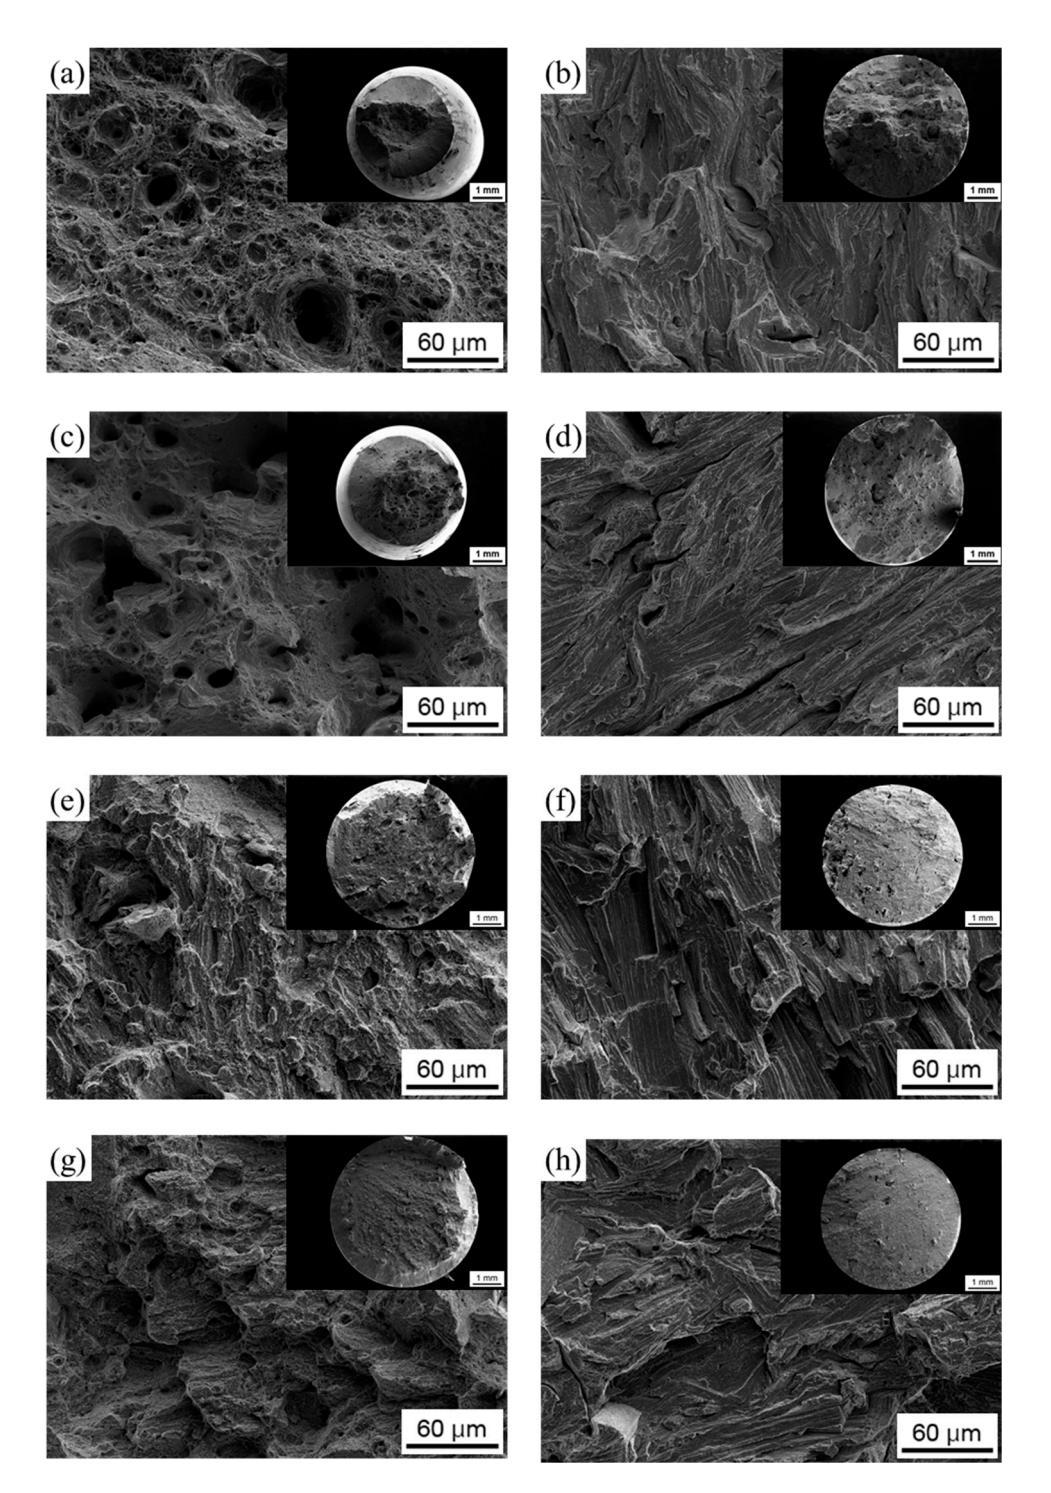
Figure 6. Fracture surfaces of (**a**,**b**) AB, (**c**,**d**) ST, (**e**,**f**) AB-aged, and (**g**,**h**) ST-aged samples; (**a**,**c**,**e**,**g**) before H-charging and (**b**,**d**,**f**,**h**) after H-charging.

SEM analysis was carried out to investigate the fracture modes of the maraging steel tested under different thermal conditions (Figure 6). AB and ST specimens showed local necking surrounding the fracture surfaces and, at higher magnification, typical fracture features of ductile materials, with dimples visible throughout the surface. H-charged AB and ST samples showed quasi-cleavage fracture surfaces with no evidence of dimples or necking. On fracture surfaces of AB- and ST-aged samples, even fewer ductile features were noticeable compared to the un-aged counterparts and evident cleavage planes appeared after H-charging.

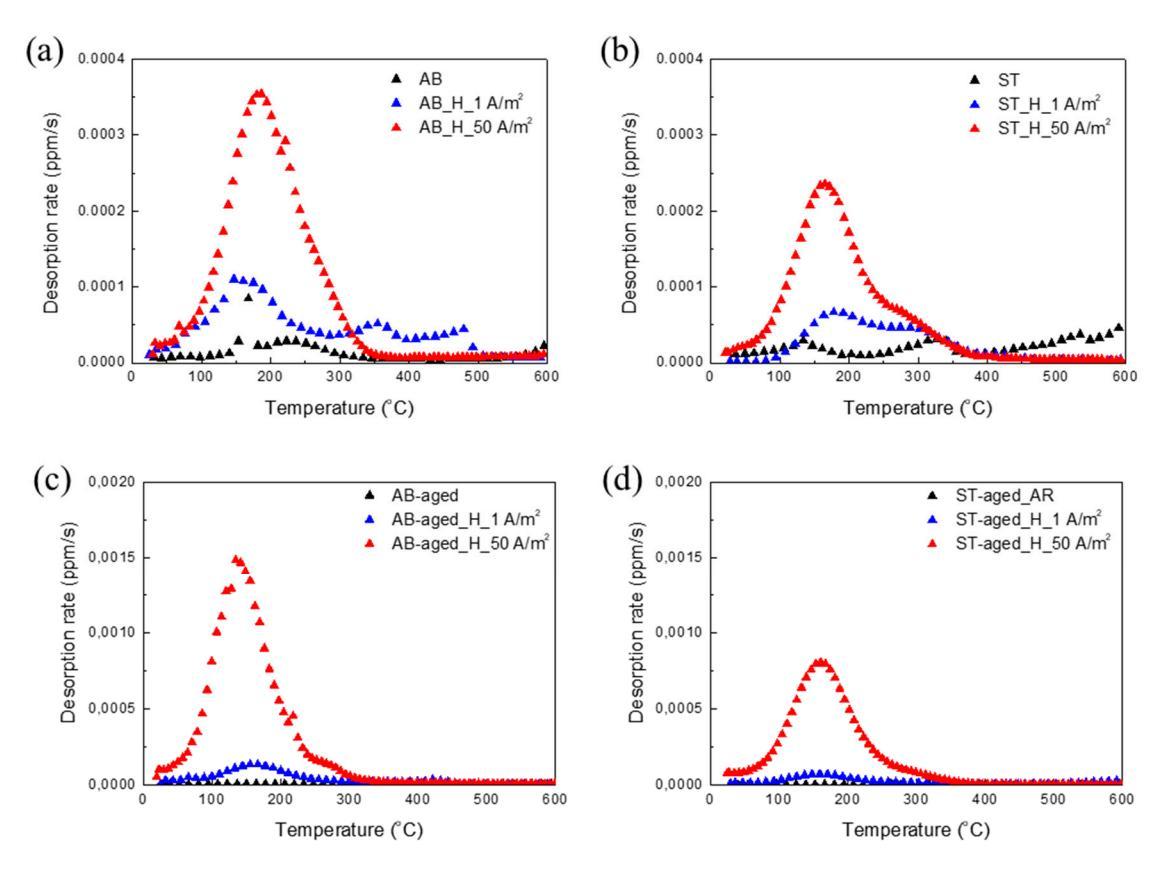
Figure 7. Thermal desorption curves for (**a**) AB, (**b**) ST, (**c**) AB-aged, and (**d**) ST-aged samples before and after H-charging at 1 A m^{-2} and 50 A m^{-2} for 48 h.

In Figure 7, the thermal desorption curves are reported for all the investigated materials and, in Figure 8, the estimated amounts of trapped hydrogen calculated as the integral of desorption rates are plotted as a function of the applied current densities. Regardless of thermal treatment or H-charging condition, the rate of hydrogen desorption gradually increased with temperature, reaching the maximum values between 150 °C and 200 °C. The total amount of trapped hydrogen evidently rises with increasing current density applied for H-charging. Furthermore, different thermal treatment routes influenced the hydrogen solubility of the steel. Indeed, the AB samples desorbed more hydrogen than ST samples and, in turn, AB-aged and ST-aged alloys released more hydrogen than their un-aged counterparts.

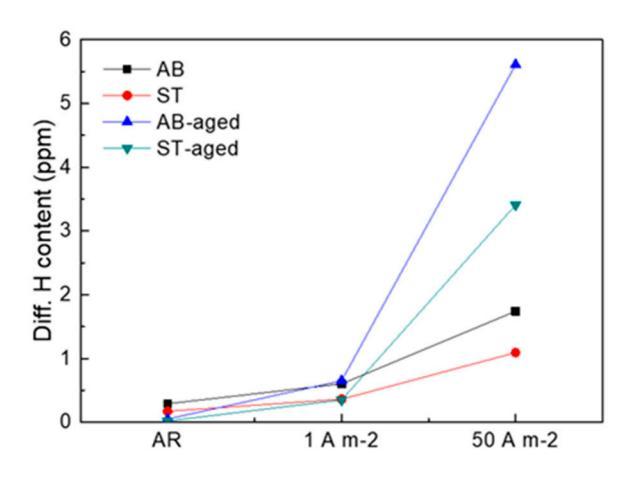
Figure 8. Overall trends of concentration of diffusible hydrogen as a function of H-charging conditions.
