## Unlocking New In-Situ Defect Detection Capabilities in Additive Manufacturing with Machine Learning and a Recoater-Based Imaging Architecture

Bugatti, M.; Grasso, M.; Colosimo, B. M.

**Keywords:** Additive Manufacturing, In-situ monitoring, Recoater-based imaging sensor.

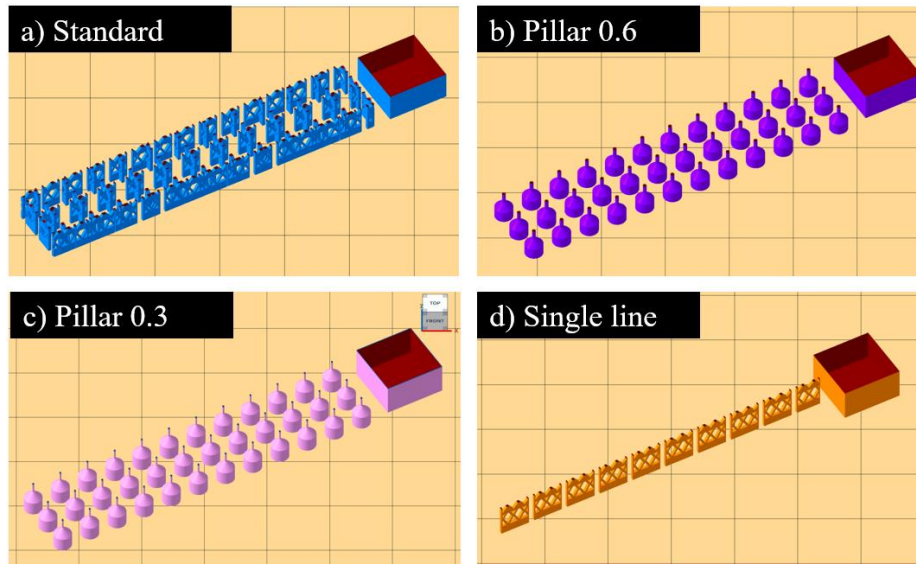
**Fig. 1.** Types of support structures

The standard support strategy (Fig. 1a) serves as a baseline to compare against the other, increasingly weaker, support structures.

The only difference between the samples is the support strategy used. The bridge-like geometry was specifically designed to enhance the stress-induced deformation. Table 3 summarizes the main characteristics of the four support structures shown in Fig. 1.

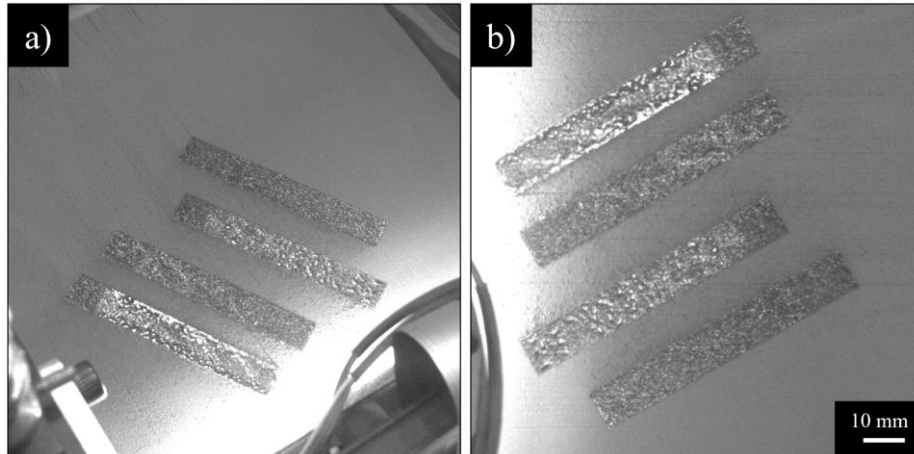
**Fig. 2.** Homography operation on external camera images, before (a) and after (b).

In a preliminary step, flat field and perspective corrections (homography) are applied to the layerwise images obtained from the recoater-mounted CIS and the external camera to get a top-down view of the build area, similar to the nominal layerwise images. The images are then registered and cropped to match the size of the corresponding nominal slice and the position of the parts. After registration, the images are smoothed and the pixel intensity is modified to correct for broad illumination inhomogeneities.

Compared to the external camera images (Fig. 2), the unprocessed CIS images (Fig. 3) already provide a close to perfect top-down view of the build platform. Only minor corrections must be performed to adjust for alignment errors when mounting the CIS on the recoater. This results in a final image that is less distorted and higher quality.

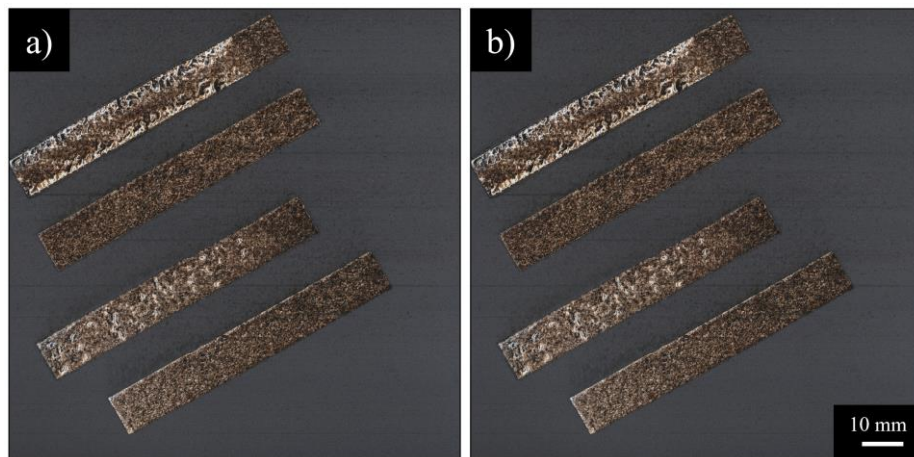
**Fig. 3.** Perspective correction on CIS images, before (a) and after (b). Almost no correction is required in this case.

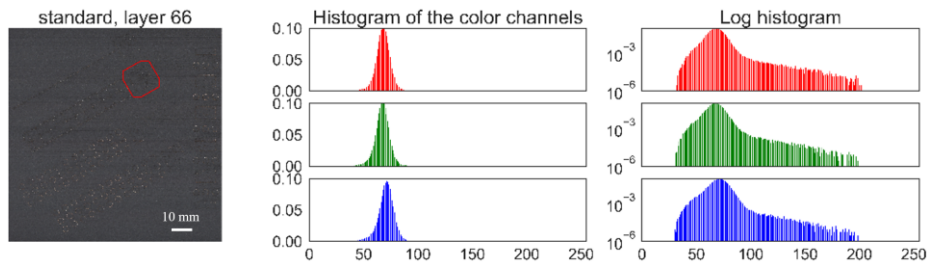
**Fig. 4.** Extraction of the empirical PDF function from the ROI.

After the preliminary steps and the image pre-processing is complete, the masking step is performed (Fig. 4). This operation makes the method completely shape-agnostic and exploits the nominal slice shape as prior knowledge about the area where to look for powder bed inhomogeneity anomalies. A “dilated” version of the mask of each part is applied to make sure to include some of the surrounding powder for reference.

However, dealing with functional datasets can be complex due to the intrinsic high dimensionality (Fig. 4). For this reason, a dimensionality reduction step was implemented. Simplicial functional principal component analysis (SFPCA) [10] was used for this task. SFPCA is a specific counterpart of the traditional FPCA which is performed within the space of density functions (Bayes space  $B^2$ ), and allows to obtain a high-quality approximation of PDFs, while preserving their constraints. This method was originally developed by Menafoglio et al. [11] to monitor the quality of metal foams from the empirical PDF of specific variables of interest. In this work, the same approach SFPCA-based was used to reduce the dimensionality of the dataset.

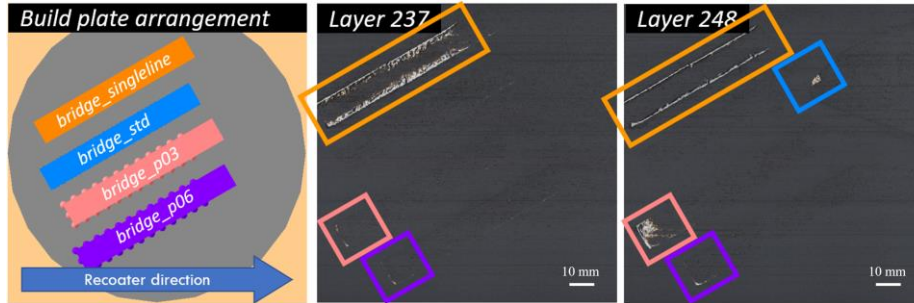
**Fig. 5.** Post-deposition images showing different stages of the warping defect in the sample with single line support.

Two main types of defects were found during the print, i.e., the presence of warping (Fig. 5) or incomplete recoating of the part (Fig. 6).

Significant warping was observed immediately after printing the first overhang layers of the least supported sample, i.e., the bridge with single line supports. The lack of anchor points on the sides of the sample resulted in a visible deformation and consequent deviation from the nominal shape.

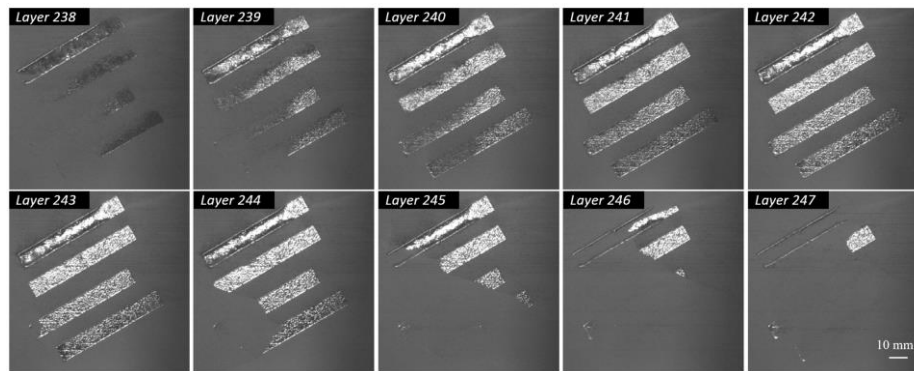
**Fig. 6.** Incomplete spreading due to insufficient powder feed (layer 238 to 247).

The incomplete spreading, on the other hand, led to a thicker layer of powder being deposited when powder supply was restored. Since the energy density was not sufficient to fully melt such a thick layer of powder, gaps and delaminations are observed at that specific layer height due to lack-of-fusion and incomplete bonding between the new layer and the existing part (Fig. 8).

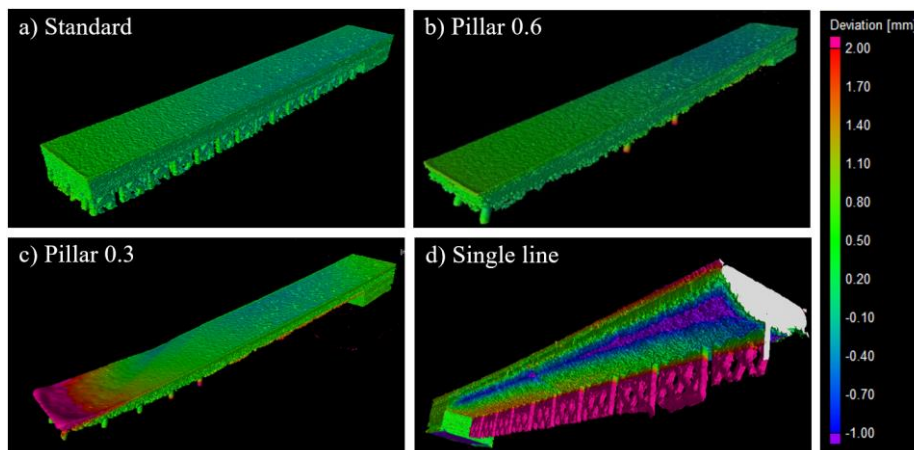
**Fig. 7.** CT-scan of the bridge samples. The most supported samples, i.e., standard (a) and pillar 0.6 (b), show little to no deformation, unlike the least supported ones, i.e., pillar 0.3 (c) and single line (d).

The samples printed with the standard and the pillar 0.6 mm support structures (Fig. 7a-b) showed no significant deviations from the nominal shape. All the supports were intact at the end of the print, which confirms that the support structures were robust enough to withstand the residual stress load.

The bridge with 0.3 mm pillar supports showed an intermediate behavior. The supports were able to withstand the residual stress load for the first few layers, after which the supports subjected to the highest load (i.e., near the edge) started to fail. The final deformation of the bridge exceeds 2 mm near its most extreme region.

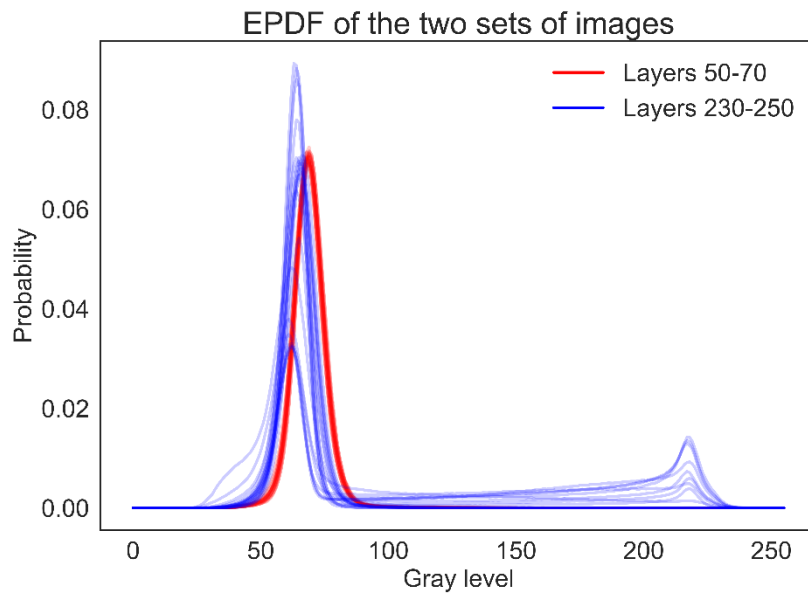
**Fig. 9.** Comparison between the in-control (layer 50 to 70) and out-of-control (layer 230 to 250) empirical PDFs (CIS images) of the standard supports sample.

When large deviations occur, i.e., an extended region of the part is not covered by the new powder layer, the empirical PDFs show a significant departure from the standard unimodal distribution that is expected in the histogram of a well recoated region. The empirical PDFs extracted from two different groups of images, in-control (from layer 50 to 70) and out-of-control (from layer 230 to 250) are shown in Fig. 9.

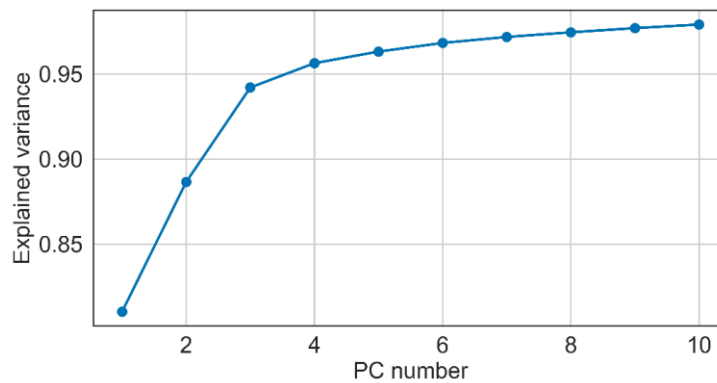
**Fig. 10.** Explained variance of each PC.

After applying the SFPCA procedure and computing the eigenvalues and eigenfunctions, it is possible to see that the only the first 2 SFPCs are necessary to retain almost 90% of the total variability (Fig. 10).

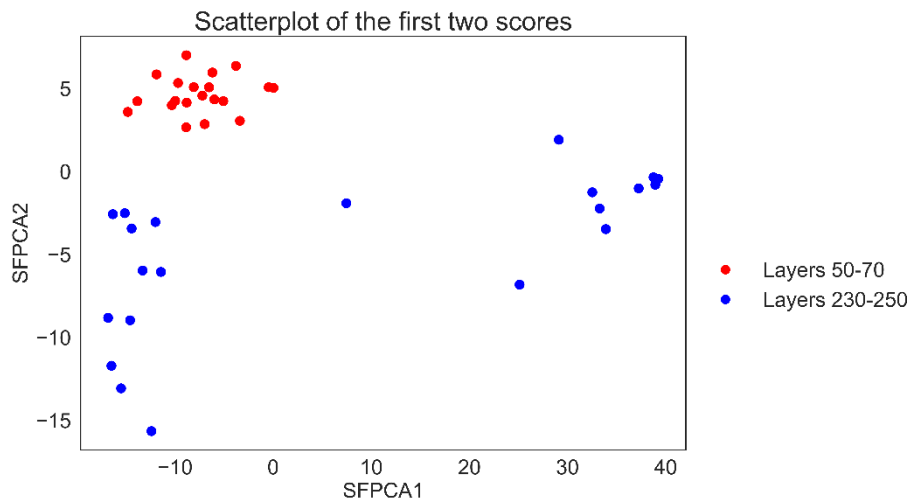
**Fig. 11.** First 2 scores of the in-control and out-of-control empirical PDFs extracted from the CIS images.

The scores for the two sets of observations (in-control and out-of-control) are shown in Fig. 11. Two well separated clusters are clearly visible in the scatterplot. This means that, just by using the first 2 scores of the SFPCA, in-control and out-of-control PDFs can be immediately identified.

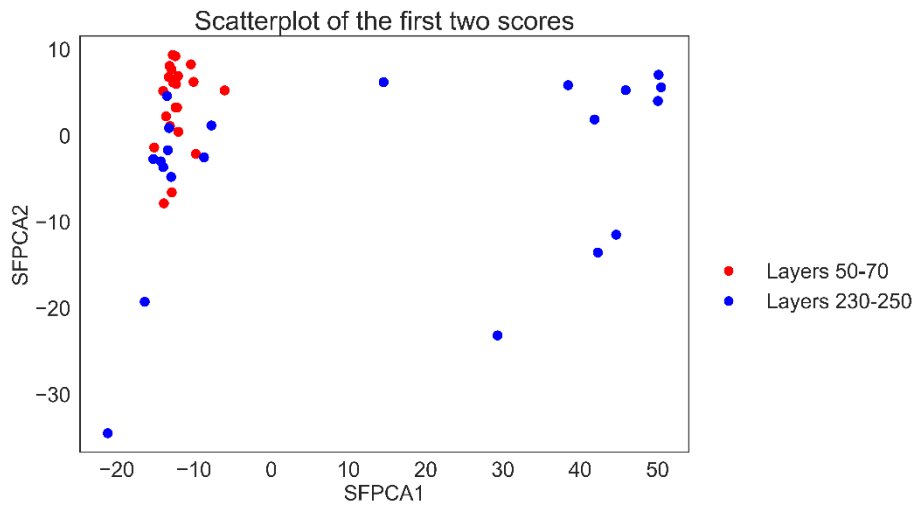
**Fig. 12.** First 2 scores of the in-control and out-of-control empirical PDFs extracted from the external camera images.

The same approach was tested on the external camera images, but the results were not on par with the CIS (Fig. 12). The separation between in-control and out-of-control clusters is not as clear and some out-of-control observations fall close to the in-control ones.

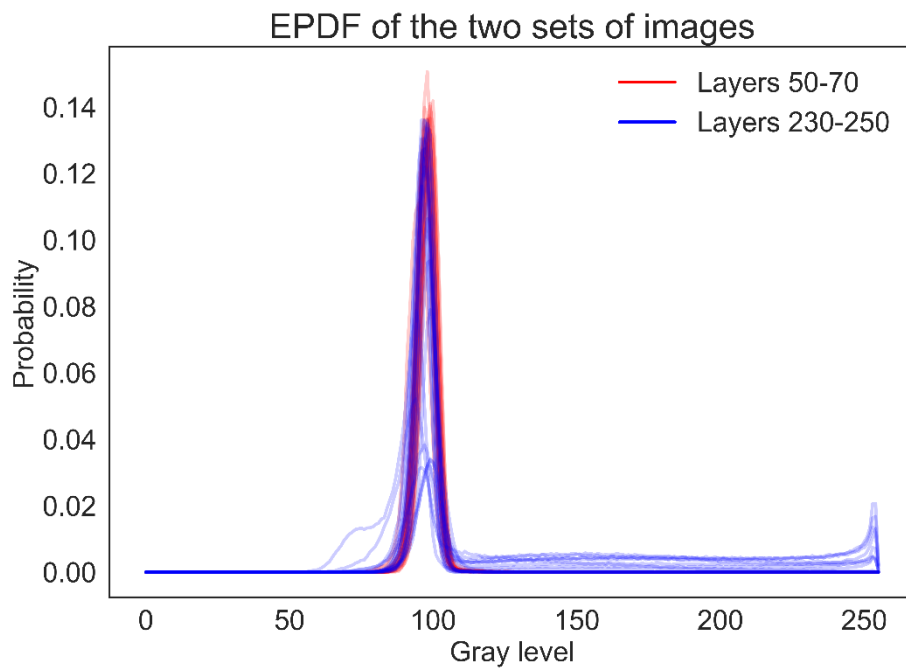
**Fig. 13.** Comparison between the in-control (layer 50 to 70) and out-of-control (layer 230 to 250) empirical PDFs (external camera images) of the standard supports sample.

Despite the layers under analysis being the exact same, the difference in performance is most probably related to the lower quality images acquired by the external camera. The empirical PDFs extracted from the camera images (Fig. 13) show a noisier distribution, even when considering only the in-control conditions. This is likely the root cause of the lower precision of the external camera at detecting shifts in the distribution using principal components scores.

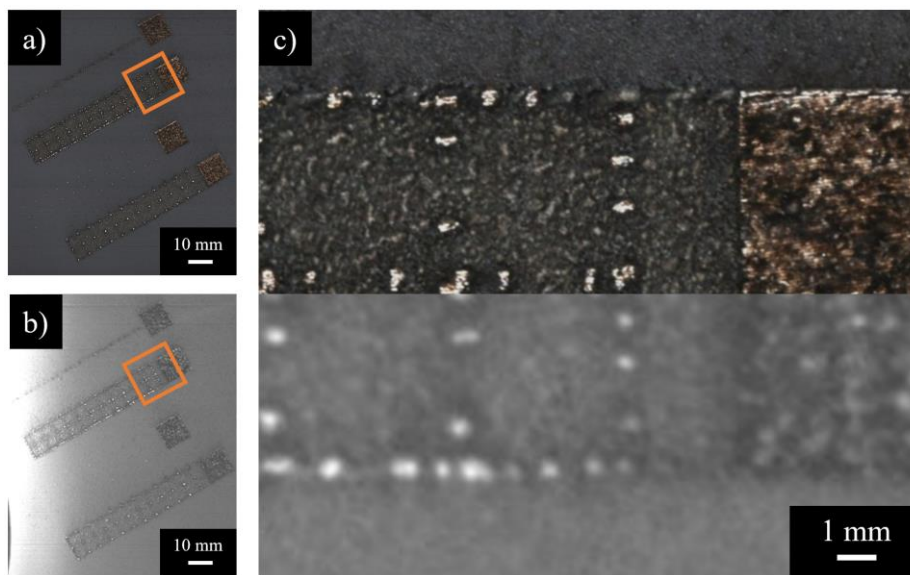
**Fig. 14.** Image quality comparison. Full images from the CIS (a) and the external camera (b) and side by side comparison (c) (CIS on the top, and camera on the bottom).

A direct comparison between the images of the two sensors is shown in Fig. 14. The CIS allows to inspect the part at an unprecedented resolution, giving the ability to observe surface patterns that are not visible to the external camera. The images of the recoater-mounted CIS provide a better contrast between the powder and the printed part, and three distinct types of surface patterns can be observed, depending on the phase of the powder, i.e., (i) fully melted powder, (ii) partially melted powder, and (iii) unmelted powder. On the other hand, the images of the external camera show a more uniform surface, with no visible differences between some surface pattern (e.g., unmelted and partially melted powder).
