# Influence of severe thermal preconditioning on the bond between carbon FRCM and masonry substrate: Effect of textile pre-impregnation

Veronica Bertolli <sup>a</sup>, Cesare Signorini <sup>b,c</sup>, Andrea Nobili <sup>b</sup>, Tommaso D'Antino <sup>a,\*</sup>

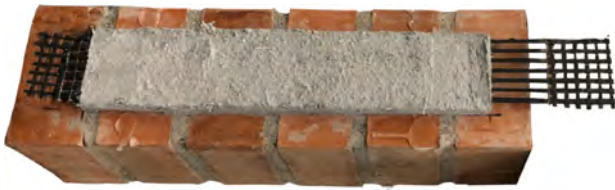
Fig. 11. Failure mode for a (control) bare textile FRCM-masonry joint (DS-C-300-60-1). Slippage of longitudinal bundles was observed without the formation of matrix crack.

the joint. At the end of this branch, the bond stress-transfer mechanism was assumed as fully established and debonding occurred at the loaded end. The stress attained at this point was defined as the debonding stress ( $\sigma_{deb}$ ). As debonding propagated along the joint, further increase in the applied stress was observed, owing to the contribution of friction at the matrix-textile interface, until the attainment of the peak stress  $\sigma^*$  [60,62]. The decreasing branch of the curve was followed by a plateau indicating that the applied stress was balanced by friction only, i.e., full matrix-textile debonding occurred [63]. The presence of friction in the final branch of the  $\sigma$ - $g$  curve was reported in various studies for various bare textile FRCMs [64–66].
