# Safety Considerations for a Distributed Electric Propulsion Aircraft: Lessons Learnt from an Automated Flight-Test Accident Involving a Research Demonstrator

## Abstract

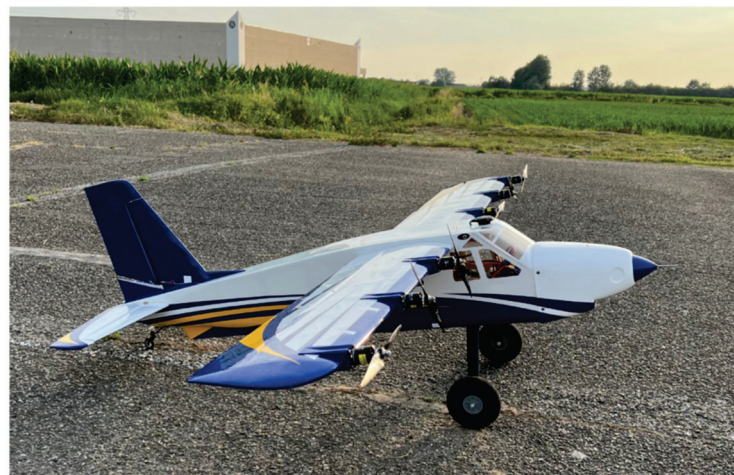
The aircraft features a 2.1 m wingspan and is equipped with six electrically powered propellers mounted along the wing leading edge, as can be seen in Figure 1. This configuration is intended to exploit aero-propulsive coupling, particularly the blowing effect of the propellers on the wing, to improve aerodynamic performance.

**Figure 1.** The SwitchMaster before a test flight.

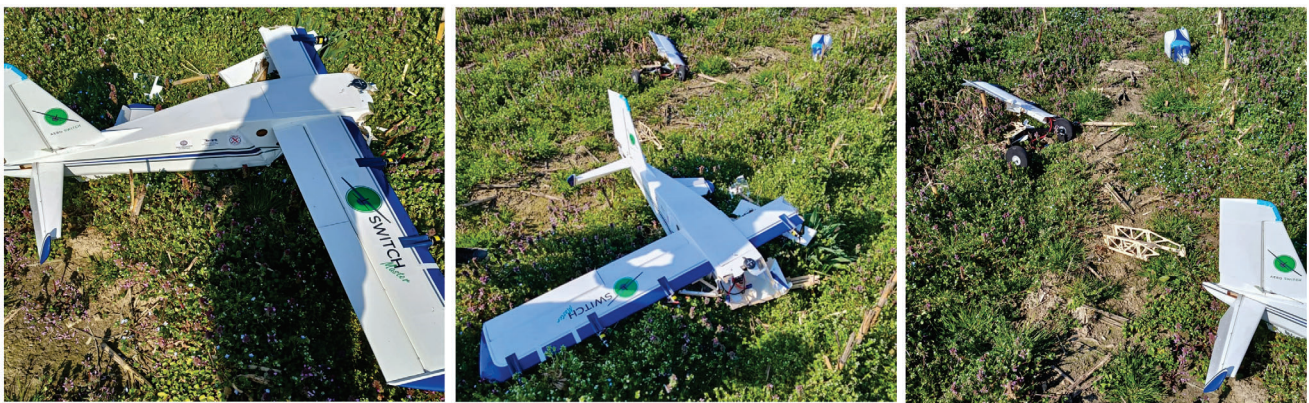
The accident occurred during the second test point of the mission while the aircraft was executing a longitudinal excitation maneuver and led to a loss of control followed by a ground impact. Figure 4 shows images of the aircraft after the accident. Despite the severe structural damage sustained by the airframe, the onboard avionics and instrumentation remained largely intact, allowing the recovery of flight logs and telemetry data used for the reconstruction of the event.

**Figure 4.** Post-accident images of the SwitchMaster research demonstrator.
