Retrofitting Masonry Walls against Out-Of-Plane Loading with Timber Based Panels

Keywords: brick walls; numerical modelling; out-of-plane behaviour; retrofit; experimental validation

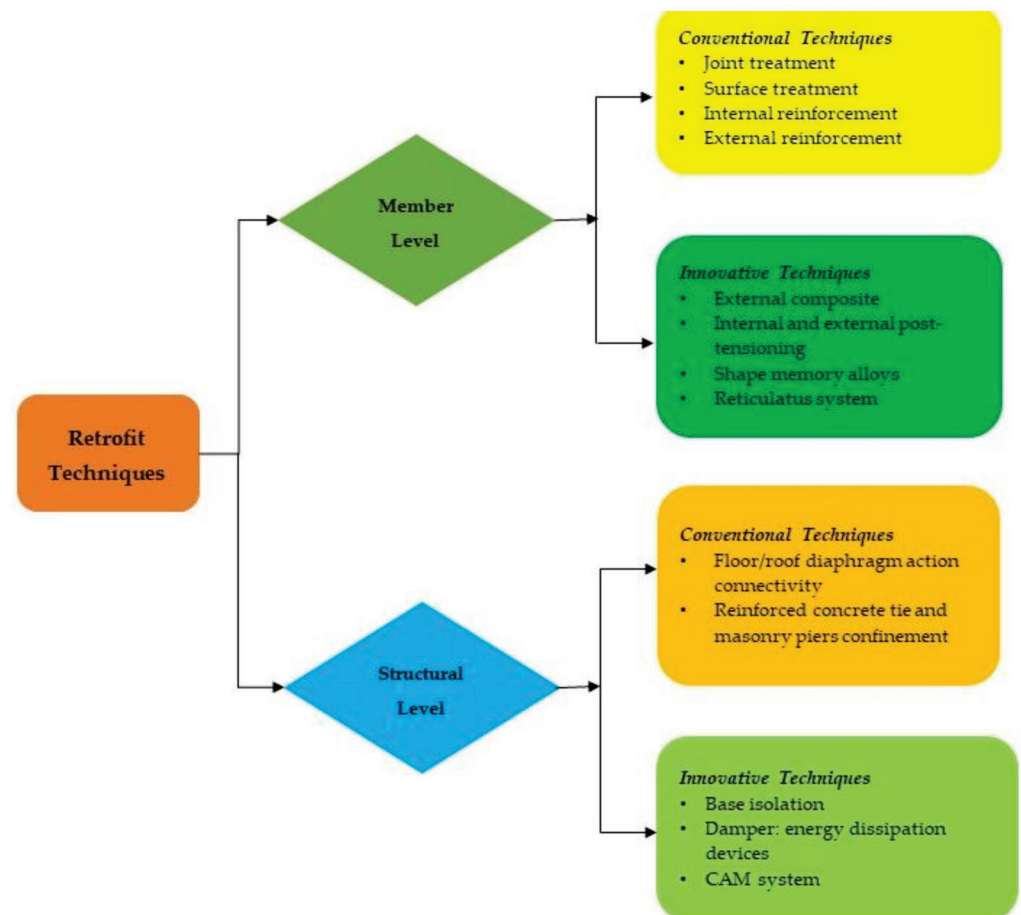
Figure 1. Classification of retrofit techniques.

Within each level of intervention, conventional and innovative techniques can be identified, as shown in Figure 1 [6].

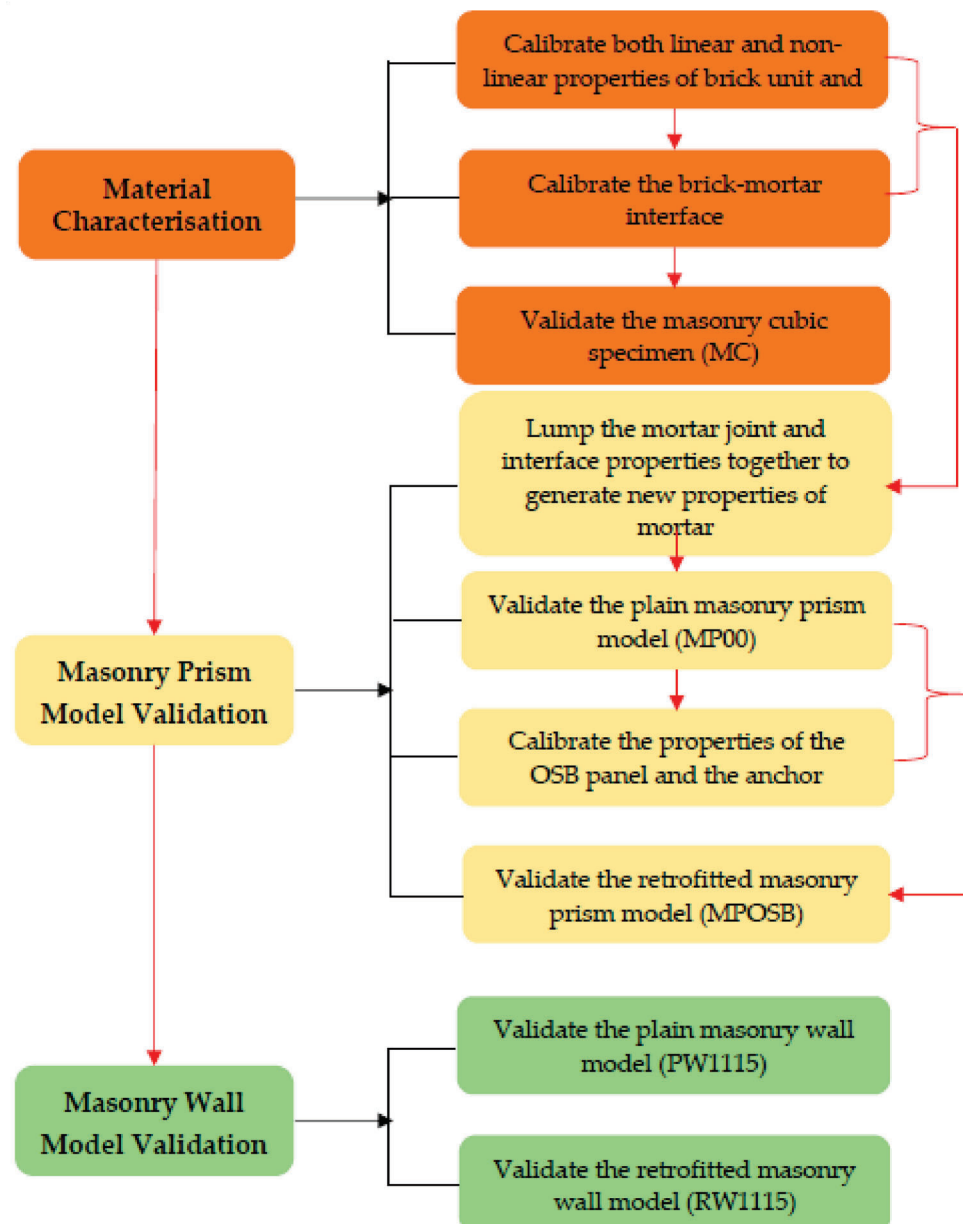
Figure 2. Full numerical analysis program.

Numerical modelling and analysis were developed in ABAQUS/CAE [26]. As formulated for the experimental work, the numerical analysis was also articulated in three stages (Figure 2).

The first stage is the numerical simulation of the compression test on the masonry cubic specimens presented as part of the material characterisation test. The purpose of this stage was to obtain accurate mechanical properties of the unit, mortar and the interfacial properties of the unit-mortar joint that is necessary to produce detailed micromodelling of masonry structures. To achieve this, a complete description of each component was done based on the experimental results of compression tests on brick units, mortar and the masonry cubic assemblage.

Second, numerical simulations of the flexural bond strength tests on small-scale masonry prisms were developed to capture the damage and failure pattern of the masonry prisms (MP) tested. This stage was articulated in two steps, which included (i) validation of

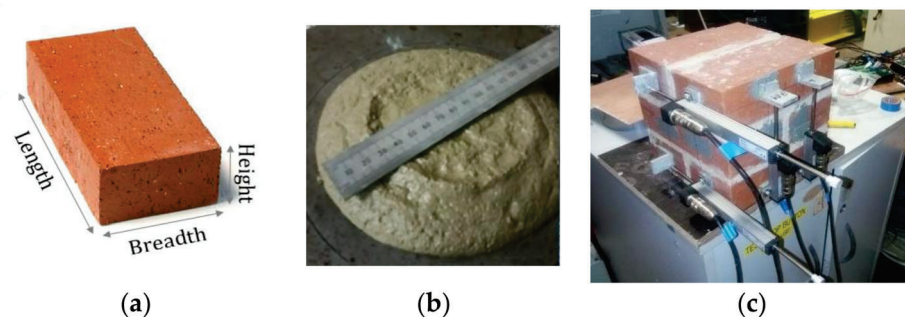
Figure 3. Material characterisation specimens: (a) brick unit, (b) mortar and (c) masonry cubic specimen.

After testing the brick unit and mortar independently, six masonry cubic (MC) specimens of $215 \times 215 \times 215$ mm were tested to understand how the selected brick units and the adopted mortar mix ratio work together. The MC specimens were constructed using English bond consisting of alternate rows of headers and stretchers, which is the oldest form of brick bond popular until the late 17th century [27]. After the construction, each sample was wrapped with polythene sheet for 14 days and thereafter opened and cured further for 14 days in the laboratory to allow the samples to achieve its standard strength. An attempt to measure the deformation of the MC was made by attaching four LVDTs to the MC before testing (Figure 3c). The specimens were carefully aligned with the centre of the ball-seated platen, under the compression testing machine, with 2 mm-thick plywood placed on the top and the bottom of the MC. A uniformly distributed load was applied gradually in equal increments continuously at 4 kN/s rate up to failure.

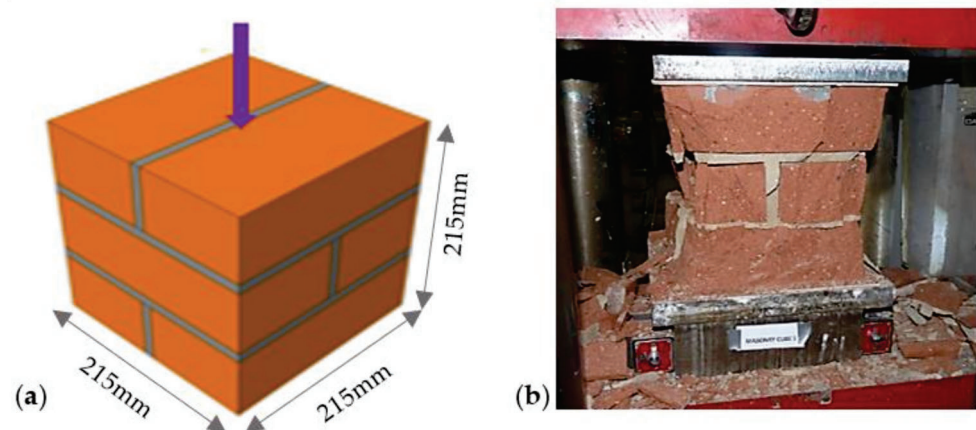
Figure 4. Masonry cubic: (a) geometry and (b) failure.

For the masonry cubic specimen, the average compressive strength obtained from the experiments was 46.4 N/mm². Most importantly, the observation shows that the failure modes of both the brick units and MC are brittle. The failures of MC specimens were characterized by vertical splitting cracks appeared first in the central unit and extended to the other units as the stress increased (Figure 4). This failure pattern is due to the presence of the vertical joints and the lateral expansion of the mortar inducing high tensile strength in the bricks.

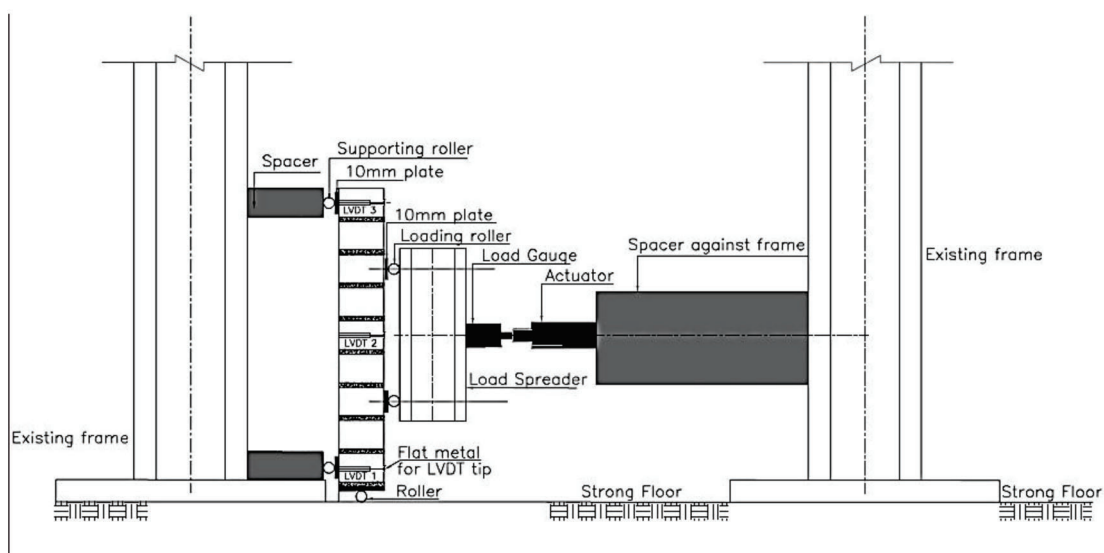
Figure 5. Small-scale test setup.

The MP specimens constructed on the 10 mm-thick steel plate were tested adopting the test set up shown in Figure 5. No vertical precompression loads were applied to any of the nine specimens. The specimen on the steel plate was rested on a 25 mm-diameter cylindrical roller with the axis of the roller parallel to the face of the specimen to allow it to freely rotate around its base while deflecting out-of-plane and prevent a restrained end condition. At the back of the specimen, a 25 × 5 mm-thick metal plate was fixed across the middle of the top and bottom brick unit each. This 5 mm-thick plate provided a smooth contact for the Ø25 mm supporting rollers fixed on an existing steel reaction frame in the laboratory. On the front side of the specimen, two additional 25 × 5 mm-thick metal plates were fixed at the third and seventh course of the specimen each to provide a contact for the loading rollers.

The loading of the specimens is such of a four-point testing arrangement, where the loads were applied on the specimen using a high-force hydraulic jack and distributed through a spreader beam. The spreader beam spanned between two Ø25 mm cylindrical rollers placed across the third and seventh course of the specimen. The direction of the load application is perpendicular to the specimen surface. The applied load on the masonry prism was monitored using a 200 kN-capacity ring load cell. Simultaneously, four linear variable displacement transducers (LVDTs) were used to record the deflections of the specimen along the centre, mid-top and bottom of the specimen.

The test was load controlled, and the loading scheme was such that an initial load of 200 N increments at every two minutes up to the occurrence of first cracks was applied. This loading rate represents 1/10th of the expected maximum load. The load increment was chosen so that a sufficient number of readings were obtained to determine definitely the load–deformation curve [16]. After the first crack appeared, the loading was increased continually at a rate of 2 N/s, up to the cracking/failure of MP specimens.

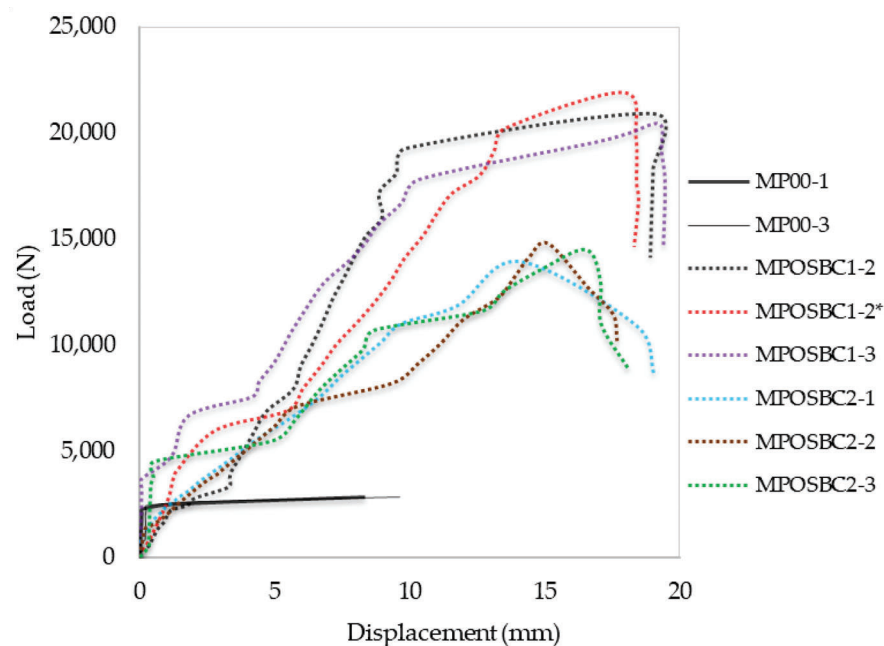
Figure 6. Load displacement curves for MP specimens. MPOSBC1-2* was constructed to replace the damaged MPOSBC1-1.

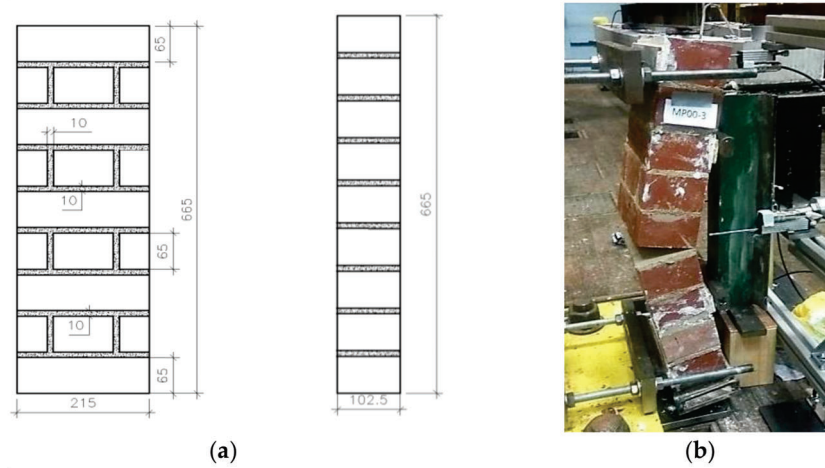
Figure 7. MP specimen: (a) geometry and (b) failure pattern (MP00-3 as an example).

the observed failure pattern of the MP specimens tested is presented in Figures 7 and 8. The maximum load, corresponding displacement at failure, flexural strength and the toughness of the tested specimens were all determined and are presented in Table 3. The flexural strength was calculated from the bending theory using the maximum failure load. The toughness (i.e., energy absorbed) of the specimens is estimated from the load–displacement curve (Figure 6) using the method based on ASTM 1609. This toughness is estimated as the overall (i.e., the total area under the load–displacement curve) and the limiting toughness. The limiting toughness is the area under the curve up to a limited displacement of span/250 [29]. This is done to understand the toughness gained by the specimens when undergoing an acceptable displacement without adverse effect. Thus, the limiting toughness actually estimates the improvement due to the retrofit application in an acceptable range.

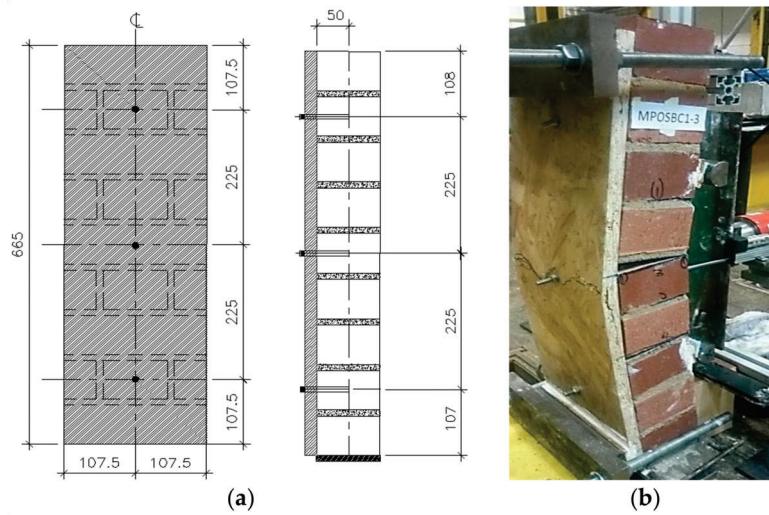
Figure 8. MP specimen with OSB: (a) geometry and (b) failure pattern (MPOSBC1-3 as an example).

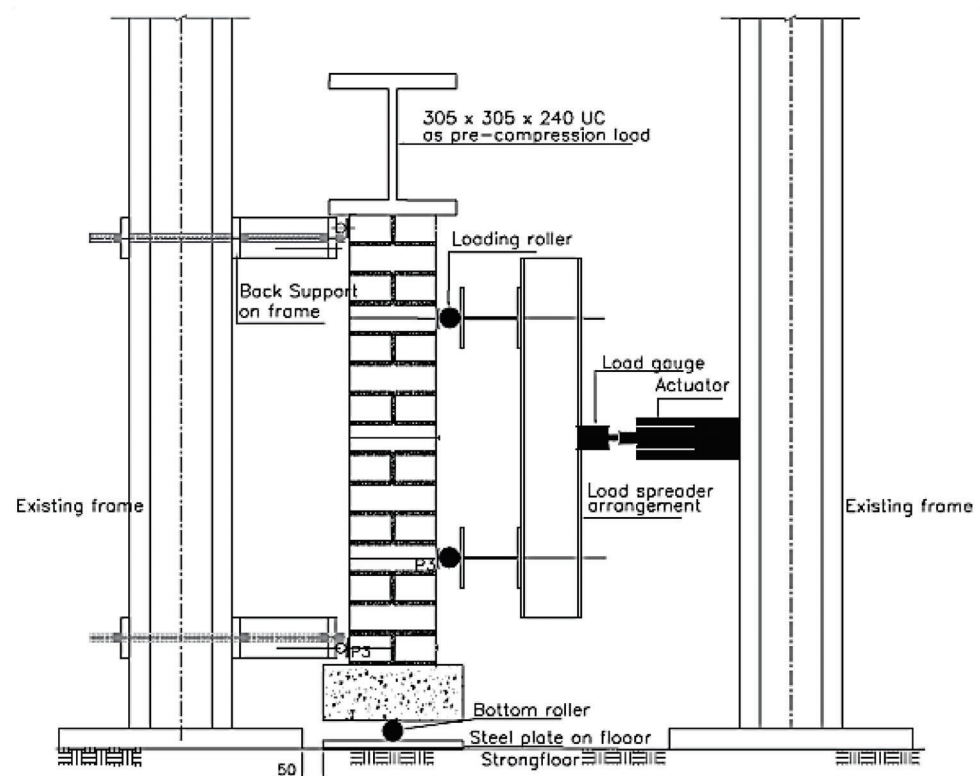
Figure 9. Large-scale test setup.

test arrangement (Figure 9) to assess their flexural behaviour. The test was load controlled and the load was applied to each tested specimen using a hydraulic ram and was distributed through a steel spreader arrangement in the central area of the wall. All specimens were tested with a simple supported boundary condition and a vertical precompression load ($305 \times 305 \times 240$ UC section amounting to a 3 kN load) on top of the wall. The specimen constructed on reinforced concrete footing was rested on a 50 mm diameter cylindrical roller with the axis of the roller parallel to the face of the specimen. At the back of the wall, a 5 mm-thick metal plate was fixed across the middle of the top and bottom course of the wall to provide contact for the simple support. Similarly, a 5 mm-thick metal plate was fixed at 1/4th and 3/4th of the specimen height at the front side to provide contact on which the loading roller rests (Figure 9).

The loading scheme was such that an initial load was applied continuously at a rate of 1 kN/min for up to 5 kN and then maintained for a 5 min period. The load steps were repeated continuously for a 10, 15, 20, 25 and 30 kN load and maintained for a 5 min period at each load step. After that, the load was increased continuously to the failure of the specimens. In order to obtain the maximum capacity of the retrofitted walls, the applied load was increased continually after the first crack until additional cracks were formed in the retrofitted specimens and ultimately the timber at the back of the masonry walls was broken. During testing, the applied load on the wall was monitored using a 200 kN-capacity ring load cell. In addition, eight LVDTs were used to record the deflections of the specimen along the wall center, mid top and bottom.

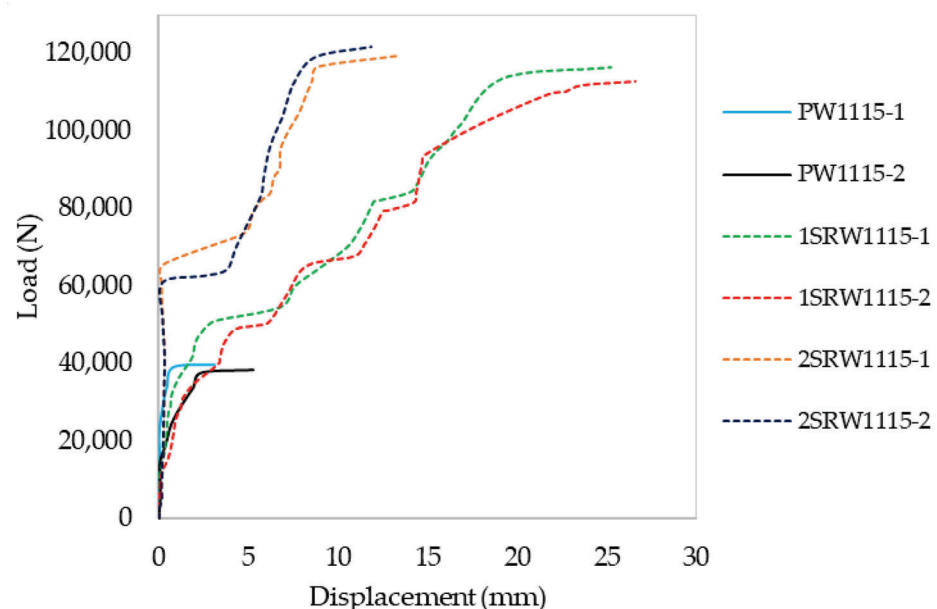
Figure 10. Load vs. displacement curve for large-scale masonry wall specimens.

The analysis of results shows a significant increase in the out-of-plane displacement of retrofitted walls. This is due to the application of the OSB timber panel that offered the masonry wall a significant lateral resistance once the mortar interfaced cracked. As such, the retrofitted specimens were able to take more loads and absorbed more energy by displacing more without sudden failure. The increment in the out-of-plane displacement of the retrofitted walls was 6 times and 3.0 times that of PW for 1SRW and 2SRW, respectively.

Similar to the observation in the small-scale test, the overall toughness gained due to the retrofit application when taken up to the failure of the OSB is such that an improvement of 16 times and 10 times that of the plain wall was estimated for application on single and both sides, respectively. However, the performance of the proposed technique at the limiting displacement was quite different with the double-sided showing more toughness gained than the one-sided application ($2.4 \times$ PW and $1.6 \times$ PW for double and single-sided, respectively). The analysis shows that the double-sided application offers the most improvement in the toughness at the limiting displacement. Thus, the double-sided is the best option when higher energy absorption is required in a real situation.

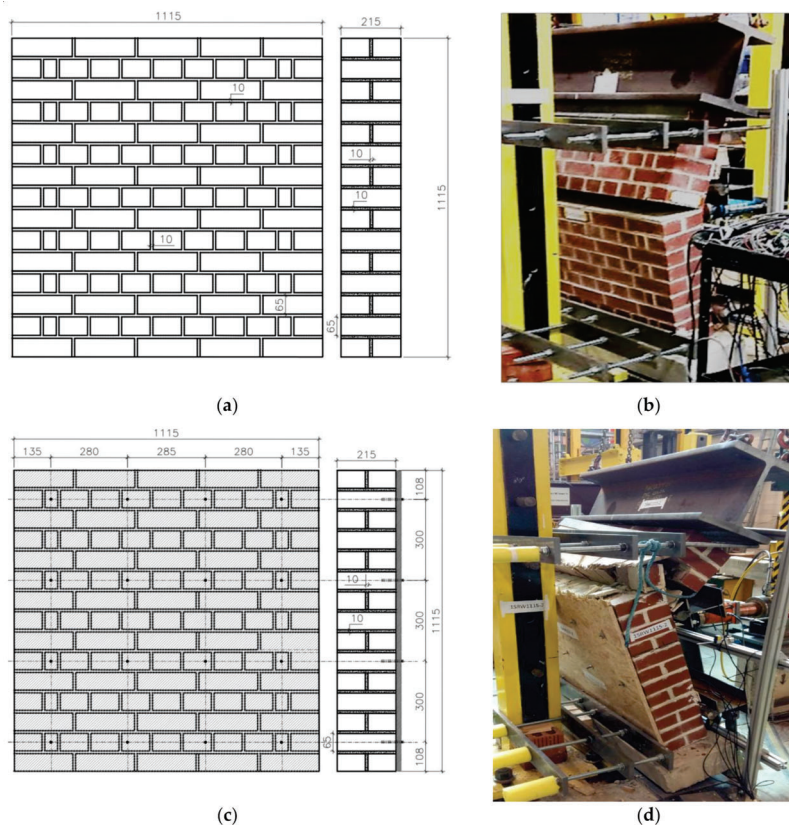
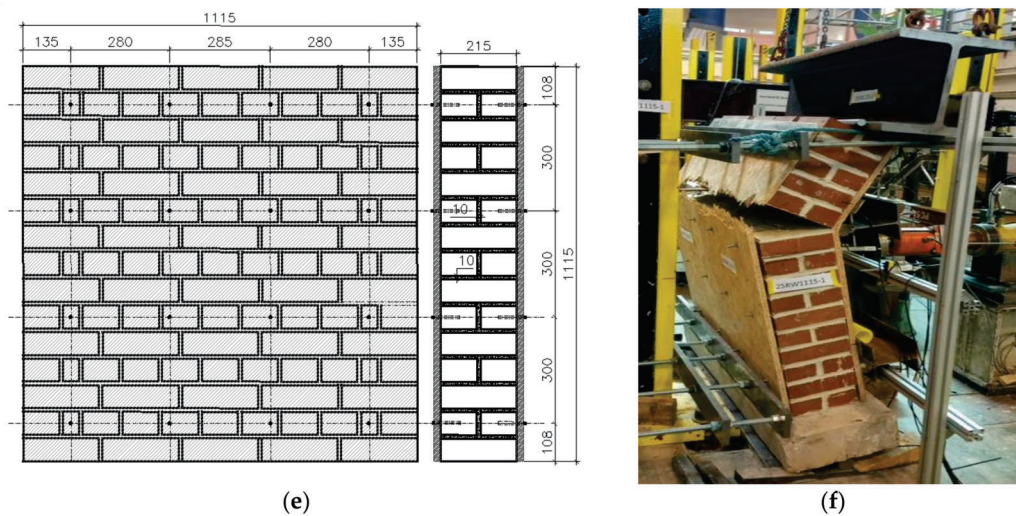
Figure 11. Observed failure pattern of a masonry wall: (a) plain wall (PW1115) geometry, (b) failure pattern (PW1115-1 sample), (c) one side retrofitted wall (1SRW1115) geometry, (d) failure pattern (1SRW1115-2 sample), (e) two side retrofitted wall (2SRW1115) geometry and (f) failure pattern (2SRW1115-1 sample).

In terms of observed failure pattern (Figure 11), it emerged that the failure of the PW was sudden with the evolution of a crack opening in the mortar bed joint almost at the specimens' mid-height. The failure (cracking) abruptly occurred between the interface of the mortar joint and brick unit, which then cut across the whole specimen thickness. Whereas the application of the OSB type-3 to retrofit the walls shows that the walls were able to take more loads after the first crack, which subsequently led to the formation of other horizontal cracks in the bed joint within the middle third of the walls. The failure/collapse

of the retrofitted specimens occurred when the applied OSB timber reached its ultimate strain and broke. The application ensured that sudden failure was avoided.

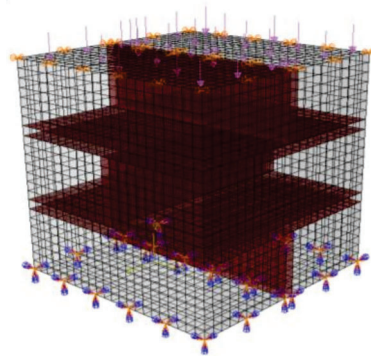
Figure 12. Masonry cubic model.

For the boundary condition, the nodes at the top of the cubes were restrained in the x - and z -direction while the bottom nodes were restrained in all the three directions (x , y , z) to replicate the friction in the test condition of the specimen. Figure 12 shows the general assemblage of the masonry cubic model, FE mesh and the boundary condition.

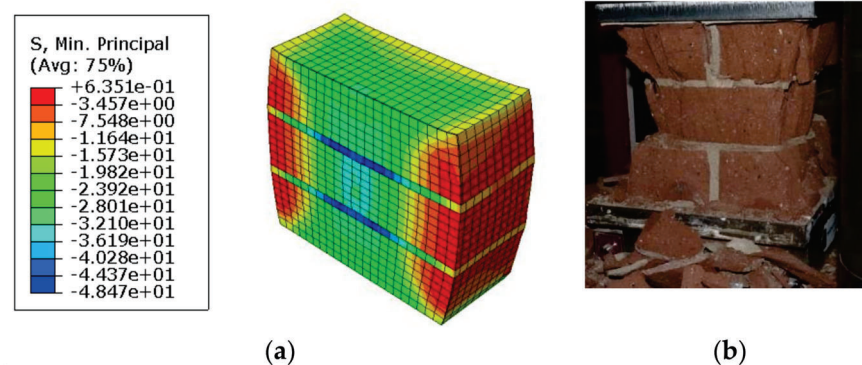
Figure 13. Numerical output for MC model (a) vs. experimental observation (b).

The principal stress obtained from the numerical analysis is compared to the average compressive strength of the specimens obtained experimentally. The maximum stress obtained from the numerical model is 48.7 N/mm^2 . This value is only 5% different from the average compressive strength of masonry obtained from the experiment (46.4 N/mm^2). Figure 13 shows the stress contour plots obtained numerically for the MC model compared with the observed failure pattern from the test. Significantly, the failure mode observed in the model output (Figure 13a) is similar to what was observed experimentally (Figure 13b) with the maximum compressive stress occurring at the bottom edges of the model. The cut along the y -plane of the model revealed the tensile stress distribution in the model. The regions showing the highest values (colours tending towards red at edges of the model) can be associated with the maximum stress, which is an indication of where cracks are expected to appear. This shows that higher concentration of the stress is consistent with the portion that split off in the experiment. Therefore, Figure 13b can be likened to the inner region of the stress diagram obtained from the numerical simulation.

The FEs model developed for the masonry cube was able to predict the behaviour and failure of masonry cube with a difference of 5% between numerical value and experimental value. This indicates that the calibrated mechanical properties of the brick unit and mortar joint represent the properties of brick and mortar used in the experiment. Therefore, Table 5 presents the already calibrated properties of the unit and joint for the small- and large-scale simulations used subsequently in Sections 4.2 and 4.3.

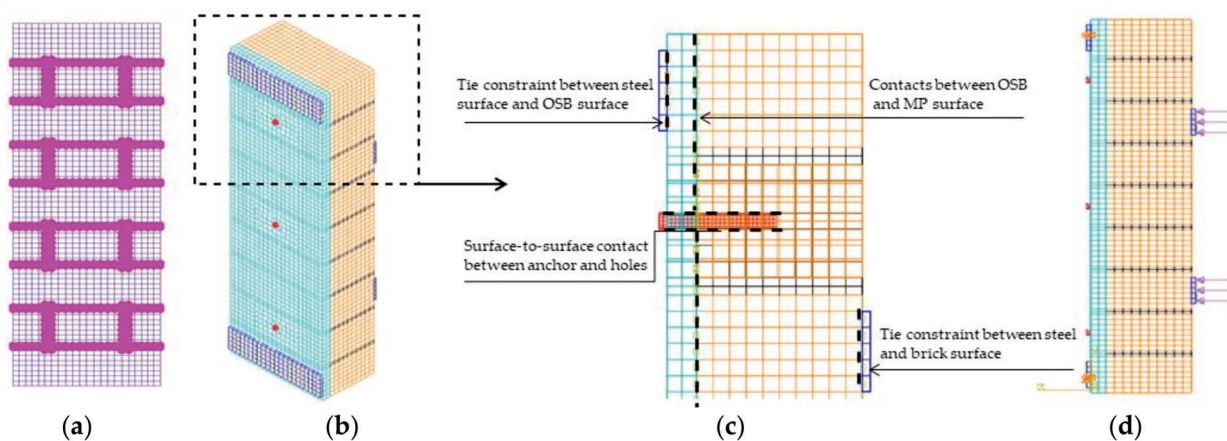
Figure 14. FE model: (a) part merging, (b) model assembly, (c) details of contact interaction between parts, (d) loading and boundaries.

Moreover, proper consideration of the applied boundary conditions in the numerical simulation was taken. The models (MP00-NM and MPOSB-NM) were constrained to replicate what was done experimentally to enable a sound basis for comparison of results. In the developed models, the nodes at the middle of the back-steel plate at the top of the MP were restrained in the x - and z -direction. In addition, the plate at the bottom was restrained in all the three directions (x , y , z) at the middle nodes to replicate the support condition of the tested specimen (Figure 14d).

The loads considered in this analysis are self-weight of the model and applied unit load in the out-of-plane direction at the third and seventh course of the model. This loading and support arrangement is a replica of the four-point bending test carried out in the laboratory. The out-of-plane load is applied as a unit uniform distributed load (UDL) on the steel plate tied to the front face of the model (Figure 14d). The analysis is the static RIKS load control method, similar to the test condition. The total load capacity of the model is measured as the load proportionality factor multiplied by the applied load in Newton (N).

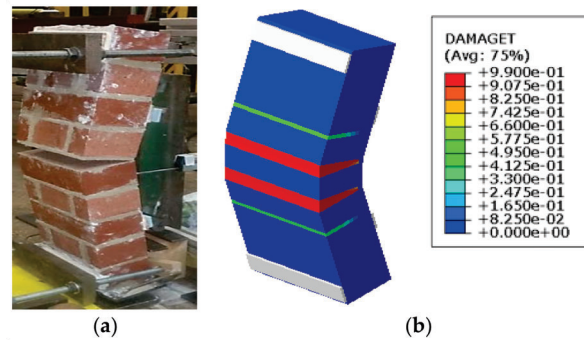
Figure 15. Failure pattern of MP00: (a) experimental; (b) FE model.

Figure 15 presents the failure of the model alongside the actual damaged specimen obtained from the test for MP00. The comparison shows that the failure of MP00-NM occurred in the bed joints within the loading span of the specimen. In the actual test, the total failure occurred in one bed joint, but the numerical model shows the failure in two symmetrical bed joints. This is because the numerical model created had the same property for all joints, which was not possible in the test due to variation during specimen construction. Hence, the symmetrical joints in the model experienced the same load, and thus the failure was simultaneous, whereas the failure occurred in the weakest joint during the experimental test.

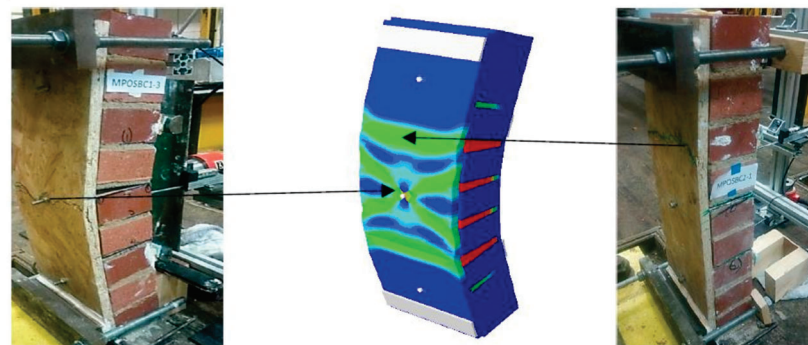
Figure 16. Failure pattern of MPOSB (experimental and FE model).

For MPOSB-NM, the damage pattern compared with the experimental observation is shown in Figure 16. In the model, the global damage pattern shows all the areas where the failure occurred in all the three tested specimens. References were made to two specimens highlighted for simplification (Figure 16). The numerical damage compared with the experimental one proves that the calibration was performed successfully for the plain

and retrofitted model since the damage pattern corresponds to one found in all three tested specimens.

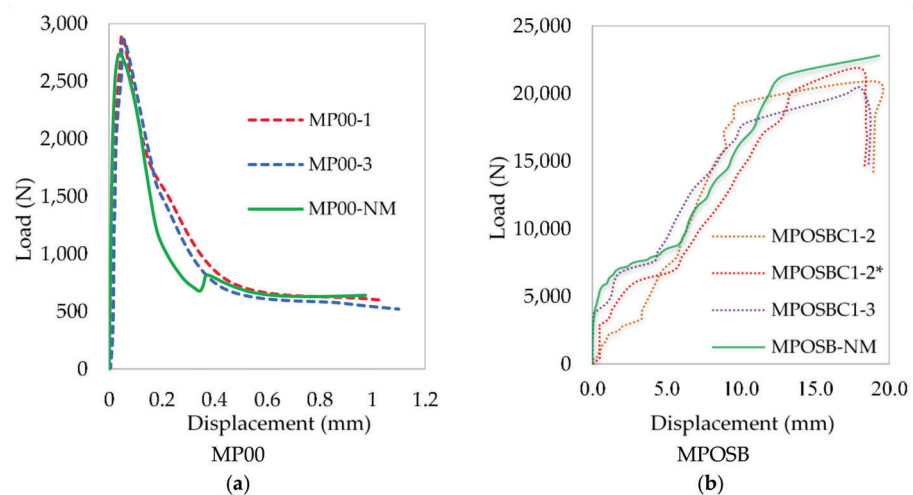
Figure 17. Load–displacement curves (experimental and FE model) of: (a) plain MP, (b) MP with OSB panels. MPOSBC1-2* was constructed to replace the damaged MPOSBC1-1.

In terms of the load–displacement comparison, Figure 17 shows that the numerical outputs compared well with the graph showing that the numerical model captures the experimental envelope. The model predicted the toughness, peak load and the corresponding failure to within less than 5% of the average results obtained from the test (Table 6). Hence, the simulation process including the input parameter, loading conditions, applied constraints and interaction between parts were fit to extend the numerical study to the large-scale masonry wall, as presented in Section 4.3.

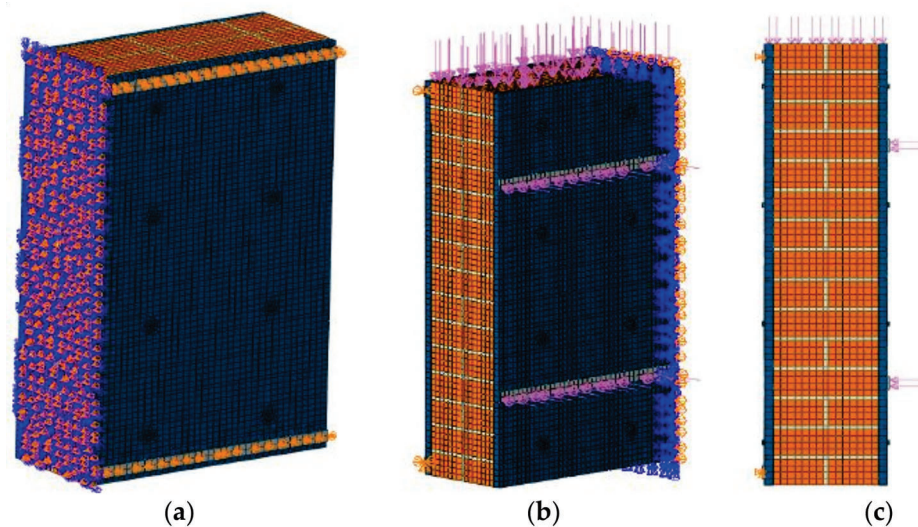
Figure 18. Masonry wall model (2SRW1115-NM as an example): (a) boundary conditions, (b) loading, (c) side view with indication of applied loads and boundaries.

Figure 18 shows the model, boundary condition and loads applied on large-scale models using the 2SRW1115-NM as an example. Due to the symmetry of the wall specimen, only half of the arrangement was modelled. Thus, another boundary condition (i.e., ZSYMM ($U_3 = UR_1 = UR_2 = 0$)) was placed in the z-axis to replicate the symmetry in the specimen. The analysis was load control, similar to the test condition, and the total load capacity of the model was measured as the load proportionality factor multiplied by the applied load.

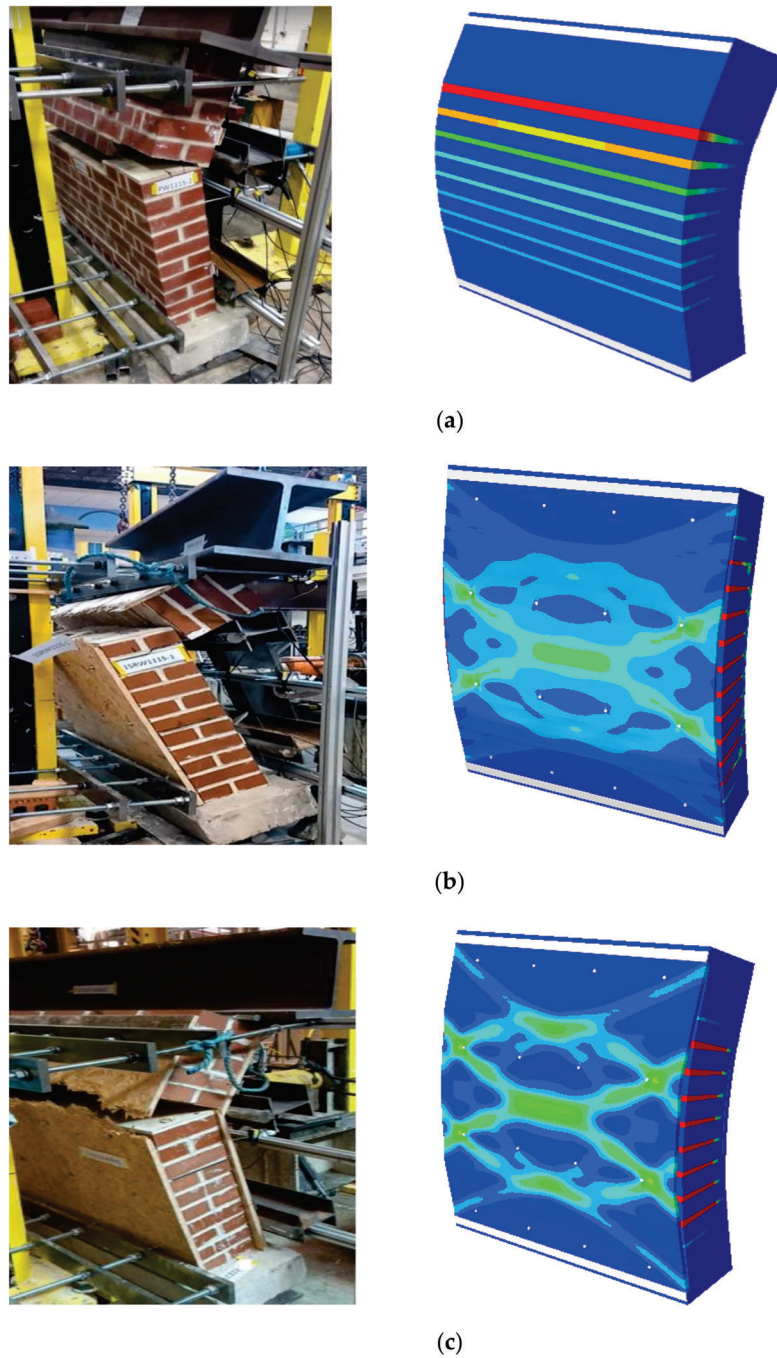
Figure 19. Failure pattern of large-scale wall (experimental and FE model): (a) plain wall (PW1115), (b) one side retrofitted wall (1SRW1115), (c) Double side retrofitted wall (2SRW1115).

The results obtained from the numerical simulation of the large-scale walls were compared with the test results in terms of both the capacity and failure mode. The comparison shows a relatively good agreement between the numerical and experimental results. Figure 19 shows the failure of the model alongside the actual damaged specimens obtained from the test. For the plain wall (PW1115), the comparison (see Figure 19a) indicates that the specimen failure occurred in similar bed joints, which is in the ninth and tenth row of

the experimental specimen. Correspondingly, the tension damage in the model is largest in the tenth row. The failure in the test specimen crossed the perpendicular joint due to the weaker zone in the perpend joint. This weakness was not observed in the numerical model because the property of the mortar joint is the same for the bed joint and perpend joint. Indeed, the bed joint is the one in maximum tension during loading. The experimental failure was only due to variance in the specimen joint during construction, which makes the perpend joint in that zone weaker than the bed joint.

Moreover, the numerical failure of the one side retrofitted model (1SRW1115) was compared alongside the damaged specimen from the test (Figure 19b). The damage pattern

shows that the OSB panel at the back of the specimen failed after the mortar joint failed. The location at which the OSB failed in the model is similar to what was observed in the test with the failure point being within two rows of connections.

Similar to the previous two models, the observed failure pattern for both the numerical and experimental specimens was compared for the two-sided retrofitted specimens, as shown in Figure 19c. The failure pattern of the model developed for 2SRW1115 is also in good agreement with the experimental failure. The damage pattern indicates that the OSB panel in the tension side (at the back of the specimen) failed after the mortar joint failed. The location at which the OSB failed in the model is similar to what was observed in the test with the tensile stresses spreading across the middle of the panel. The OSB in the compression face did not fail, as also seen in the experiment. The damage shown on the OSB on the compression side (i.e., loading face) only occurred after the failure and, as such, not replicated in the model.

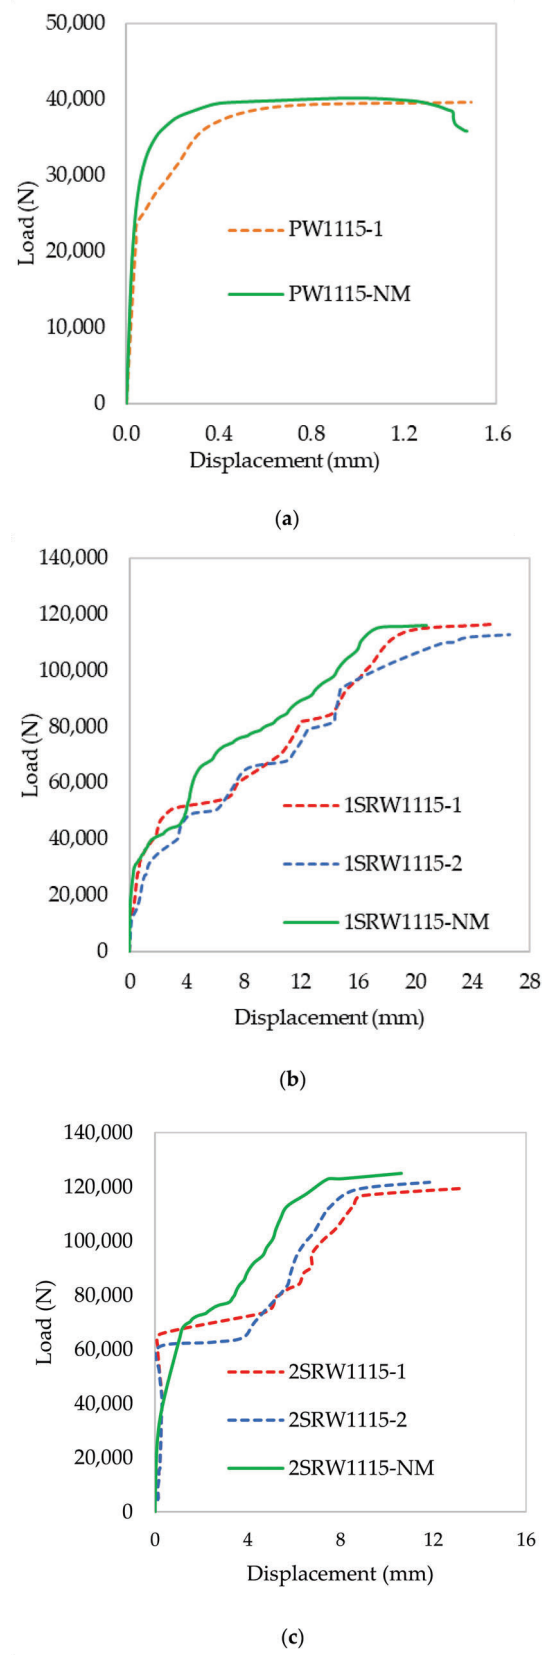
Figure 20. Load–displacement curve for the large-scale model: (a) plain wall, (b) one-side retrofitted wall, (c) two side retrofitted wall.

Additionally, the load–displacement curve obtained from both the numerical analysis and experimental test is presented in Figure 20. The toughness, maximum load and corresponding displacement at the failure of the model are within less than 10% of the average results obtained from the test (Table 7). Figure 20a shows that there is a little variance in the displacement for applied load higher than 24,000 N; this variation is due to the movement of the wall during testing at the initiation of the crack. This behaviour was noticed during the experiment ([6]); and it is primarily due to instability of the specimen caused by the test arrangement (as also indicated in [34,35]). However, since the numerical model assumed a perfect arrangement, the response is not captured and will be ignored.

In addition, the load–displacement curve for both the experimental and numerical model for 2SRW is presented in Figure 20c. Again, the difference between the numerical curve and experimental curve, especially at the dilatant parts of the curve after 65,000 N and subsequent steps, represent the jump in the displacement of the specimen. This jump is attributed to the stability issue in the specimen, which happened after the joint bed failed during testing. The inference from the load–displacement curves means that the model developed agrees with the experimental results. The difference in the maximum load and corresponding displacement of the numerical model and the experimental results is also within less than 10% of the average test results shown in Table 7.
