## **BANK EROSION AND INSTABILITY MONITORING WITH A LOW COST TERRESTRIAL LASER SCANNER**

D. Brambilla <sup>1</sup>, L. Longoni <sup>2</sup> and M. Papini <sup>3</sup>

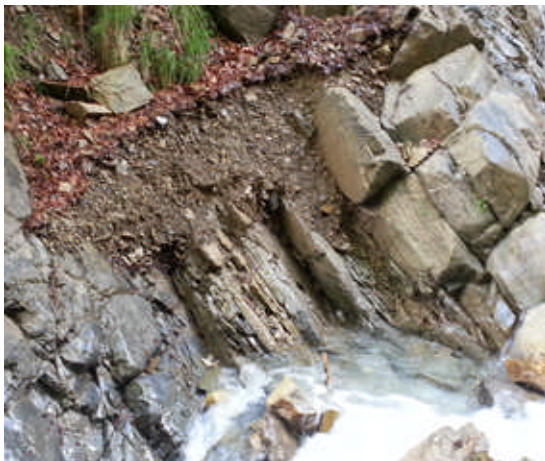
In the measured area, a narrow bed, cut into bedrock, with typical steps and pools structure, characterizes the river (Figure 1). Karst phenomena are widespread in the whole basin; problems related to excessive sediment yield are common during the rainy periods, in particular during autumn, and affect not only the little village on the alluvial fan, subjected to little floods and gravel deposits but also the drinking water supply facilities. The test site has been individuated in a small bank in a steep narrow canyon just upstream of the alluvial fan; the objective was to monitor the evolution of the bank to assess its role in debris discharge. The bank is roughly ten meters long, two high and formed by angular pieces of rock coming from a fault. This kind of material is quite different from usual studies, which focus on plain rivers eroding thin materials such as sand or clay. (Nasermoaddeli & Pasche, 2008).

Figure 1. Test bank

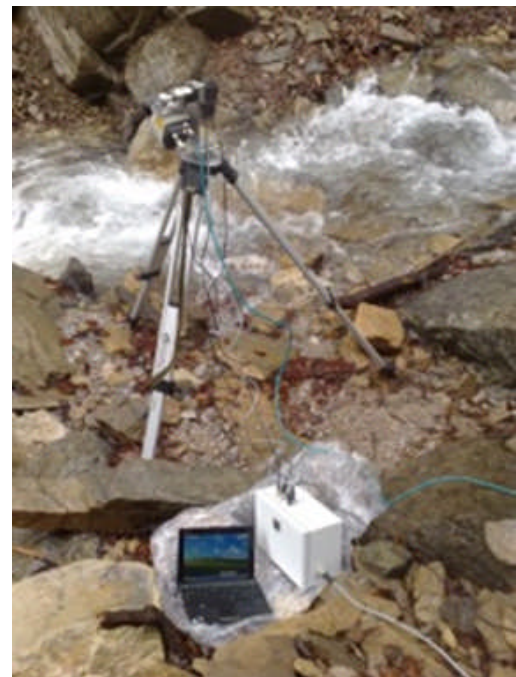
The laser scanner used was developed by ISSweb srl, a spin off society of Politecnico di Milano, starting by a Sick bi-dimensional commercial laser (Figure 2). The laser works on TOF (time of flight) principle and in its original version is used to scan a plane around itself for industrial safety purpose; coupling this laser to a stepper engine is possible to scan different lines rotating the scanner, and thus the scanning plane, and obtain a 3D point cloud. The laser management software does the transformation from angular coordinates to Cartesian one automatically and data are saved as x y z coordinates of each point scanned. This laser scanner is normally employed for contactless measure and recognition systems in industrial applications at close distance; due to this general purpose during tool design scan speed was

preferred to measurement accuracy and resolution. Laser can acquire a complete scan of 180° both in vertical and horizontal direction, acquiring the complete scene in front of it, in less than 2 seconds. The scanner is not able to record the reflectivity of the objects but only the mere distance not allowing for high reflectivity targets recognition for point clouds alignment.

Figure 2. Tool deployed on field

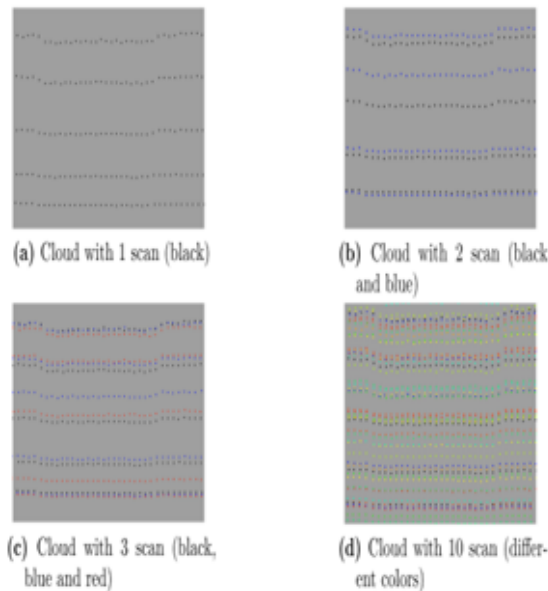
positioning is calculated in 37 mm and is the sum of errors in both distance measure and angle measure due to the transformation from spherical to Cartesian coordinates. Due to the intrinsic positioning error of the stepper motor each time the laser finishes a scan cycle and moves back to the starting position a little difference between the final and initial position exists; this difference leads to a progressive thickening of the cloud, as seen in Figure 3. This result is highly positive and give the chance to acquire dense point clouds useful for bank erosion assessment. These dense clouds, including millions of points, can be cleaned and interpolated to improve data quality; the objective of the interpolation is double: regularize the cloud and eliminate possible errors.

Figure 3. Clouds thickening due to multiscan procedure

This operation is executed in one single passage by a specifically Matlab developed algorithm: a square window move through the point cloud space from (Min x; Min y) to (Max x; Max y) and put a single point in each square whose x and y coordinates are the ones of the square centre, while z values is the mean of z values of each points inside the window. Comparison between different acquisition is made by a simple point to point comparison of different scans, that need to be of the same dimension.

of the bank, from the same station point, until the target number of scan is acquired. This technique usually referred to as multiscan and its aim is to increase the number of point acquired and thus the resolution of the point cloud in respect of a single scan. This passage is extremely important when dealing with a low resolution scanner allowing for an inexpensive increase of tool performance. The scanner is not able to record the reflectivity of the objects but only the mere distance, due to this limitation is possible to relocate the tool in the same point at any epoch but not to measure high reflectivity targets for point clouds alignment.
