FE PUSHOVER ANALYSES OF A 20TH-CENTURY MASONRY CHIMNEY IN SPAIN: COLLAPSE BEHAVIOUR AND NUMERICAL UNCERTAINTIES

Alessandro De Iasio¹, Gabriele Milani² and Jose M Adam³

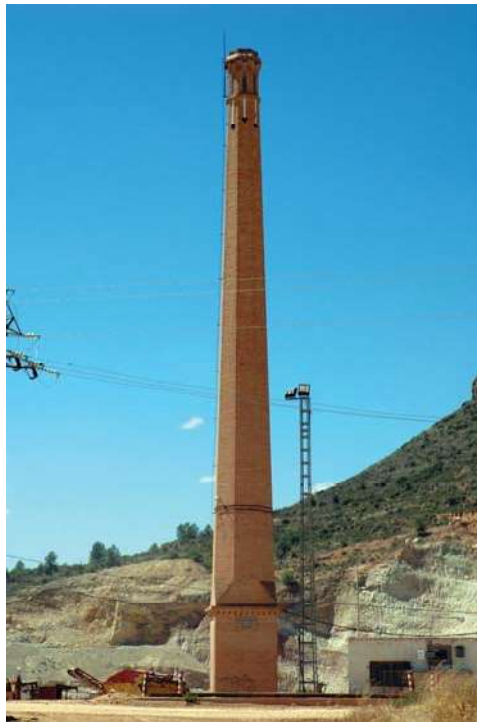
Figure 1: The chimney located in Villar del Arzobispo (Spain) used as a case-study of this research.

This paper aims to study the ultimate behaviour of such structures by using some pushover analysis carried out with Abaqus/CAE and applied to a real case-study: a 20th-century masonry chimneys located in Villar del Arzobispo (Spain) (Figure 1). It is almost 28m high, and the base edge is 2.4m long. The base cross-section is a square and became octagonal after almost 5m from the ground. A small opening is present on one of the base facades, and it is directly connected with the flue, which runs from the base to the top of the chimney with the same shape as the exteriors. Figure 2 shows the 2D technical drawing of the chimney.

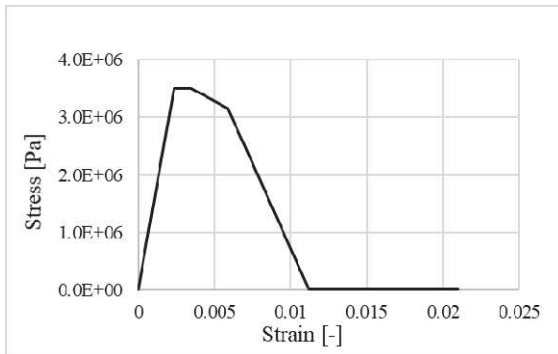
Figure 5: Compressive stress-strain branch to define the compressive CDP part in Abaqus.

. The compressive behaviour has been modelled by a brickwork feasible stress-strain relationship (Figure 5), while the fracture energy approach has been used for the tensile behaviour (Figure 6). The fracture energy has been computed by Eq. (1) as suggested in [28], and it is equal to 8.1 N/m.

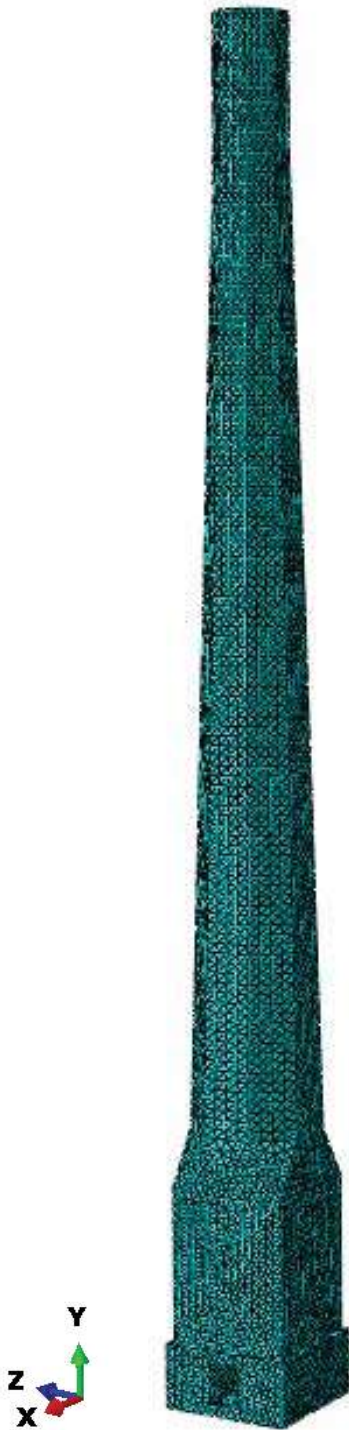
Figure 7: The meshed model .with 3D elements

The chimney body has been meshed through the Abaqus's automesh command. A seed dimension equal to 0.2m has been input, and linear tetrahedral elements of type C3D4 has been chosen. The model has a total number of 17289 nodes and 79666 elements. Figure 7 shows the meshed body, being possible to see that the discretisation is very refined. The element dimension may be considered adequate since the elements are linear.

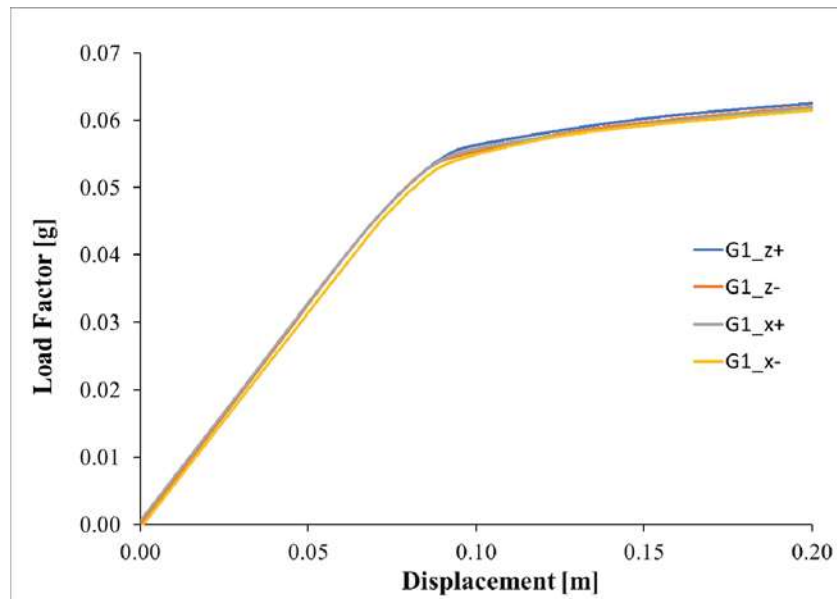
Figure 8: Capacity curves of the pushovers along the four principal directions.

Figure 8 shows the pushover analyses' capacity curves along the four principal directions using a G1 load distribution. It is worth noting that the four curves almost coincide; therefore, the singularities of the chimney body, i.e. the small opening at the base, doesn't play a crucial

role in the seismic response (differently from [26], in which it has been shown that the opening at the base of the case-study pagoda constitutes a weak point for the overall dynamic response). Figure 9, instead, presents a comparison between the G1 and the G2 loads' application along the $z+$ direction. As expected, the ultimate capacity in the latter case is higher.

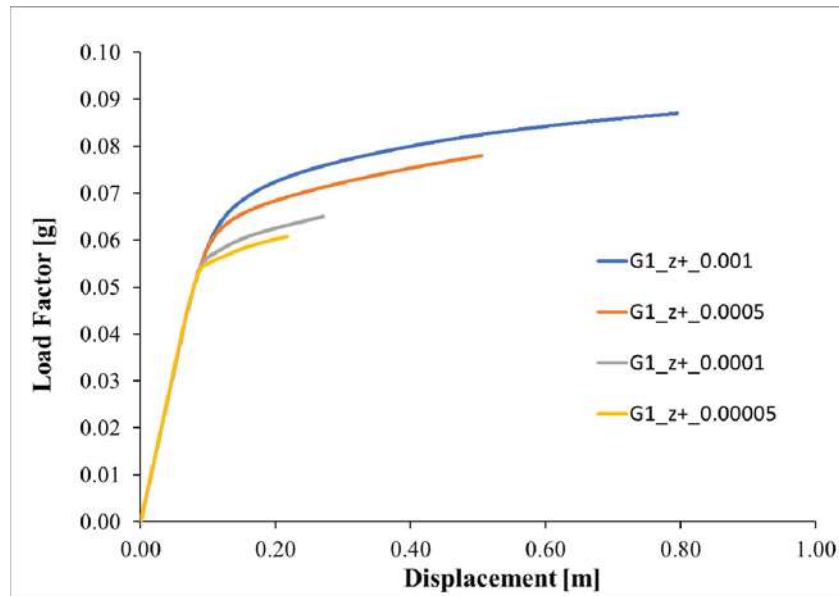
Figure 11: Sensitivity analysis on the viscosity parameter value.

Figure 11 shows the results of the sensitivity analysis. It is noticeable that the ultimate capacity significantly increases when the viscosity parameter is incremented. Moreover, the capacity curve's length is directly proportional to the viscosity parameter's value (the total load

increments number is fixed to 1200). The authors expected both the latter facts since the viscosity parameter smooth the yield surface and helps the steps' convergence and speed up. Increasing the viscosity parameter also increases the efficiency of the analysis by allowing larger load increments at each step but overestimate the ultimate capacity. Therefore, those who use the Concrete Damage Plasticity model in their studies must be aware of that and critically analyse the analyses' results also in light of the selected viscosity parameter's value.
