# Structural Assessment of Cultural Heritage Buildings Using HBIM and Vibration-Based System Identification

A. Calì, A. Saisi, C. Gentile

**Abstract.** *The paper exemplifies the application of the methodology involving historic and architectural research complemented by HBIM and operational modal testing in the structural modelling of a heritage palace, the Galleria degli Antichi in the historic town of Sabbioneta (Italy), included in the UNESCO World Heritage list since 2008. This monumental building was built in the 16th century. Full details on the history of the building and the information obtained in the non-destructive survey are given in the paper. The good knowledge of the structural geometry, along with the complete inspection carried out and the large number of identified vibration modes, allowed to establish a numerical model of the monumental building for a first quantitative assessment of its structural condition.*

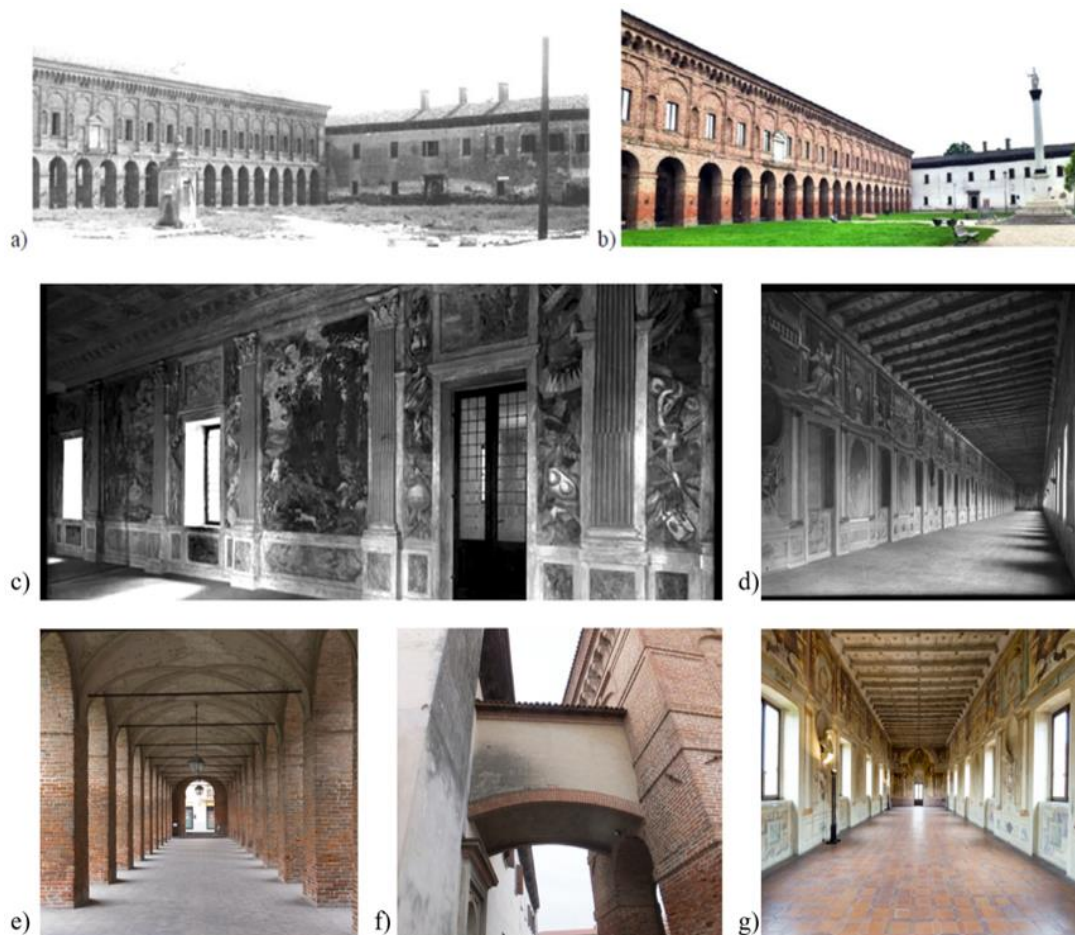
**Figure 1.** Historic (a) and current (b) views of *Galleria degli Antichi* and *Palazzo Giardino*. Historic (c-d) and current (e-g) views of different parts of *Galleria degli Antichi*.

The *Galleria degli Antichi* is characterized by a long open arcade at the ground floor with 27 couple of massive squared columns made by brick masonry (Fig. 1e) supporting cross-vaults. The structure of the gallery is made by brick masonry (Figs. 1a, 1b and 1e). At the first floor, the building has a long gallery with 26 windows each side (Fig. 1). The gallery walls were

frescoed and stuccoed in a very refined way by famous painters and craftsman of the time (Figs. 1c, 1d and 1g) [13-14]. The gallery is covered by wooden lacunar ceiling with panels richly decorated but apparently in a low state of preservation (Fig. 1g).

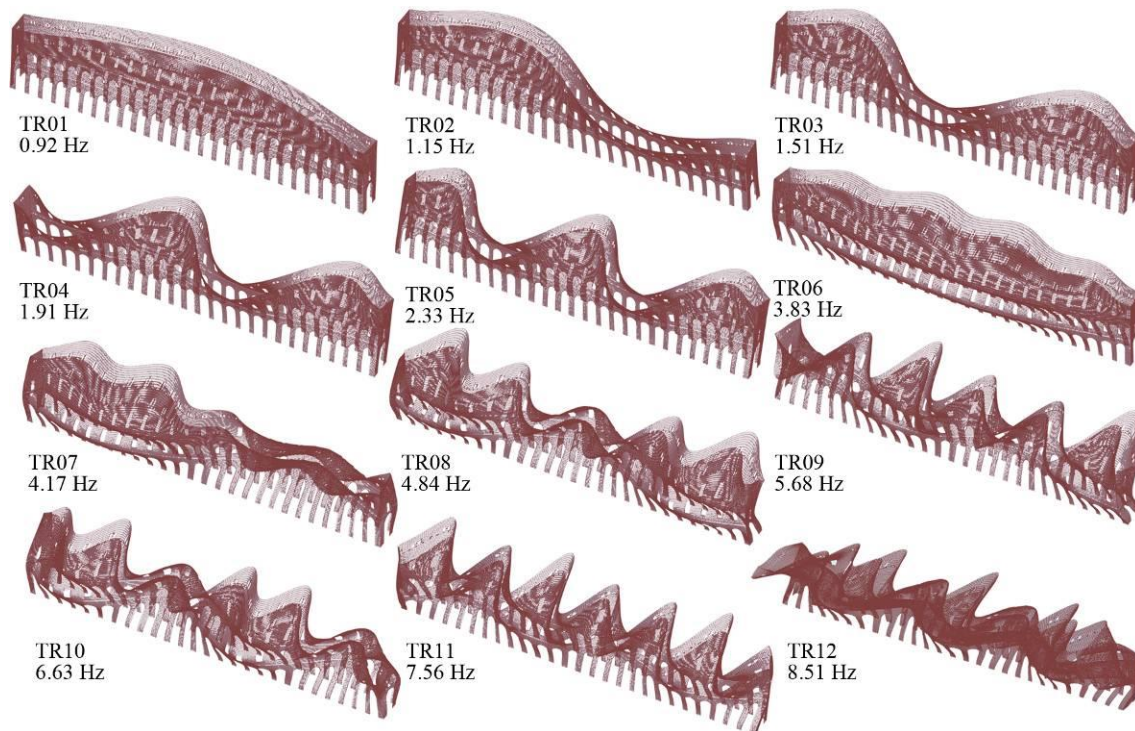
Selected mode shapes and natural frequencies of the FE model are reported in Fig. 4. As it has to be expected, most of vibration modes involves bending in the transversal direction of the building and the overall structure exhibits a sequence of normal modes similar to the one of a beam supported by springs (Fig. 4).

Figure 4. Selected (transverse) vibration modes of the FE model.

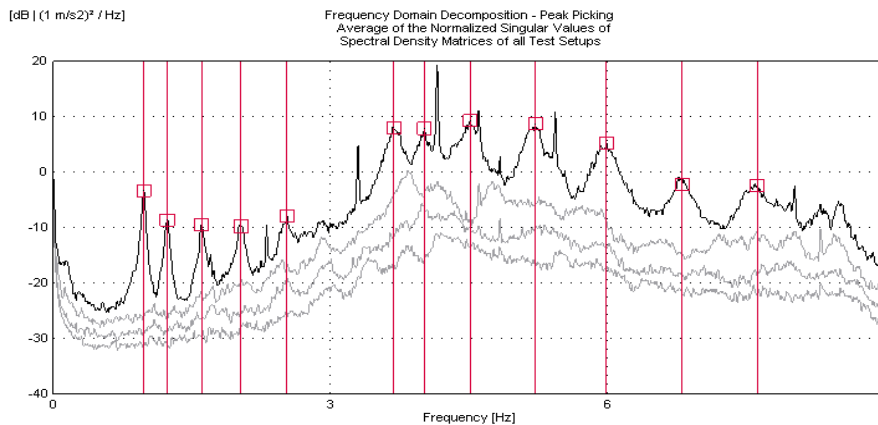
**Figure 6.** First singular value lines and identification of natural frequencies (FDD).

The application of the Frequency Domain Decomposition (FDD) technique [16] implemented in the commercial software ARTeMIS [17] to the collected time series led to the identification of 12 transverse vibration modes in the frequency range of 0-9 Hz. The results of OMA in terms of natural frequencies can be summarized through the plot of Fig. 6, showing the first singular value lines (SV) of the spectral matrix. The inspection of Fig. 6 clearly highlights that the FDD technique provides a clear indication of the building modes through well-defined local maxima in the first SV. The corresponding mode shapes are shown in the upper part of Fig. 7.

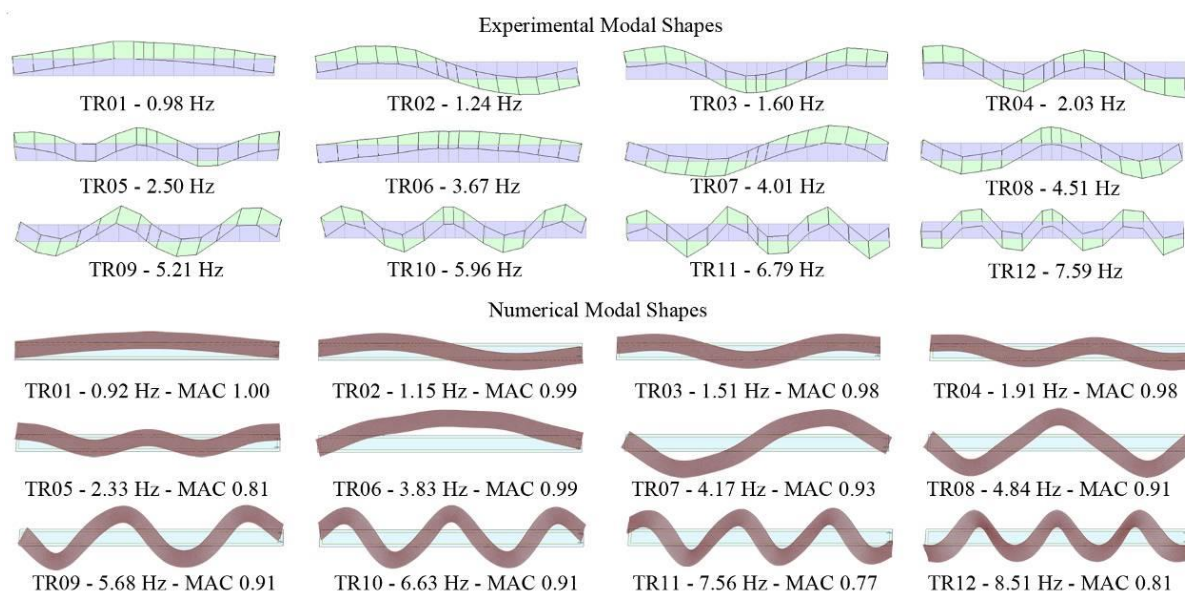
Figure 7. Comparisons between experimental and numerical mode shapes at the first-floor level.

The Modal Assurance Criterion (MAC) [18] and the combined frequencies and MAC parameters (FMAC) were used to compare the experimental and numerical modal characteristics. The correlation between the dynamic characteristics of the base FE model and the experimental results is shown in Figs. 7 and 8. Figure 8 shows imperfect correlation, with frequency discrepancy  $DF [=100 \cdot (f_{FEM} - f_{EXP}) / f_{EXP}]$  ranging up to about 12% and an average distance between experimental and natural frequencies of 7.76%. However, the correlation between theoretical and experimental behavior, notwithstanding its roughness, seems to provide a sufficient verification of the model main assumptions (and hence of the whole H-BIM workflow), being a one-to-one correspondence between the mode shapes, with the worst

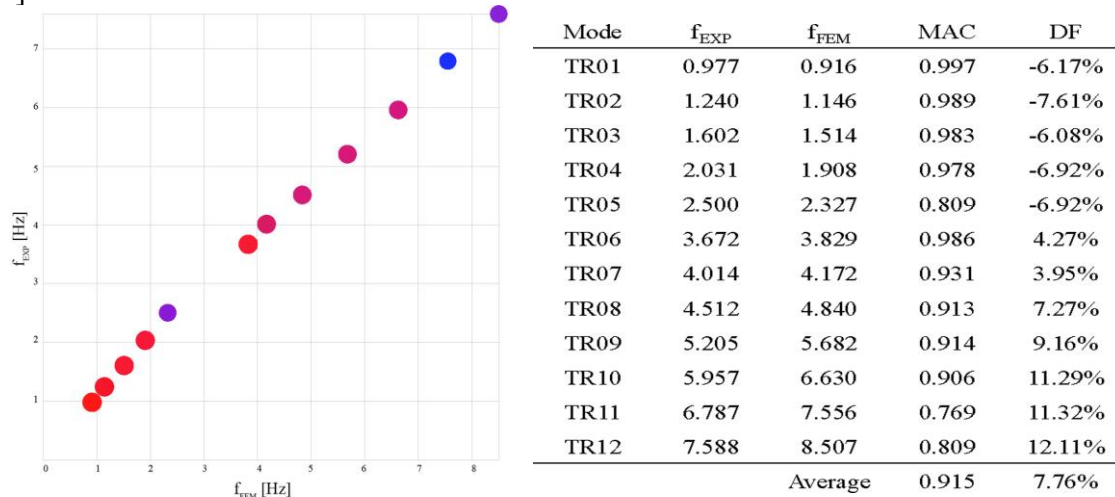
MAC value being 0.77.

**Figure 8.** Modal Assurance Criterion (MAC) and frequency discrepancy (DF) between experimental and numerical modes.

The imperfect correlation between the FE model and the experimental results is conceivably due to the very simplified assumptions on the to the elastic properties of the masonry and should be improved by updating the distribution of the masonry Young's modulus over the building [5-6].
